Access Appraisal and Audit
for the
Cheltenham Art Gallery and Museum,

Access Appraisal and Audit.

Cheltenham Art Gallery and Museum

21st of January 2004

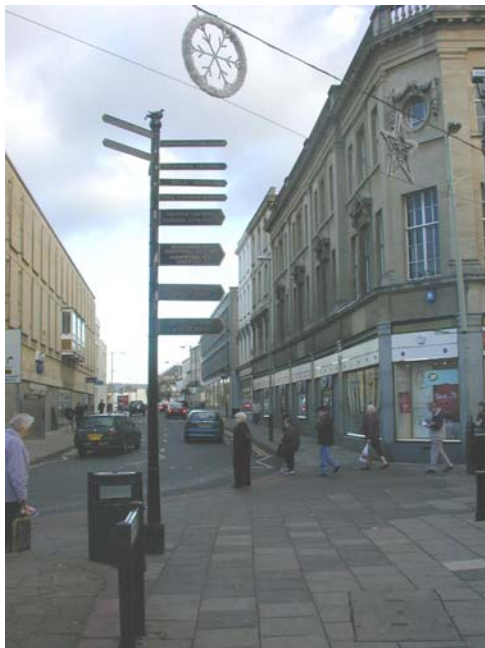
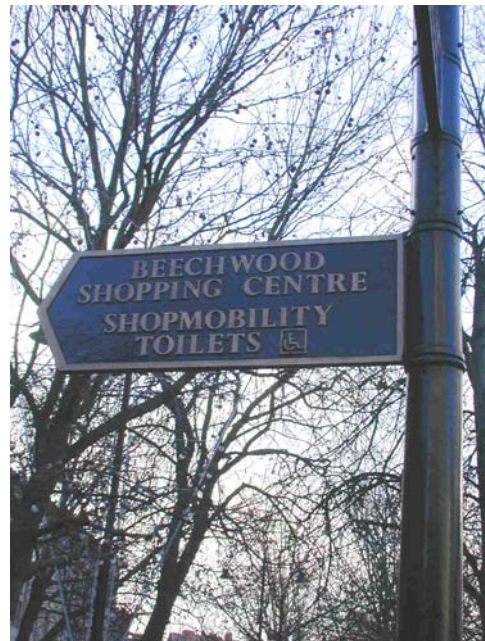
Signage around the town is not good for people who are trying to locate the building; the signs are at a high level, are all in upper case and are hard to read, being gold lettering on a black background.

On the pedestrian route to the facility there are bollards which are painted black and gold, these units are common throughout the town centre and appear to contrast well with the paved street scene.

1. Door opening mechanism to be reviewed with regard to the amount of effort required to open the door. If possible adjust the door to open more easily. This applies particularly to the main entrance, the café door and the meeting room door.
2. Improve signage particularly the style and positioning of signs which identify the position of the accessible WC facility.
3. Up-grade accessible toilet facility to conform to current good practice.
4. Provide induction loop for use in the reception area.
5. Review system of access to the building.
 - Review operation and design of lift
 - Review and adjust access route from the rear of the building.
6. Consider the provision of systems that would allow people with poor hearing or eyesight to use the facility. Large print signage or preferably the use of audio tapes linked to exhibit points.
7. Review the design of the reception desk facility.

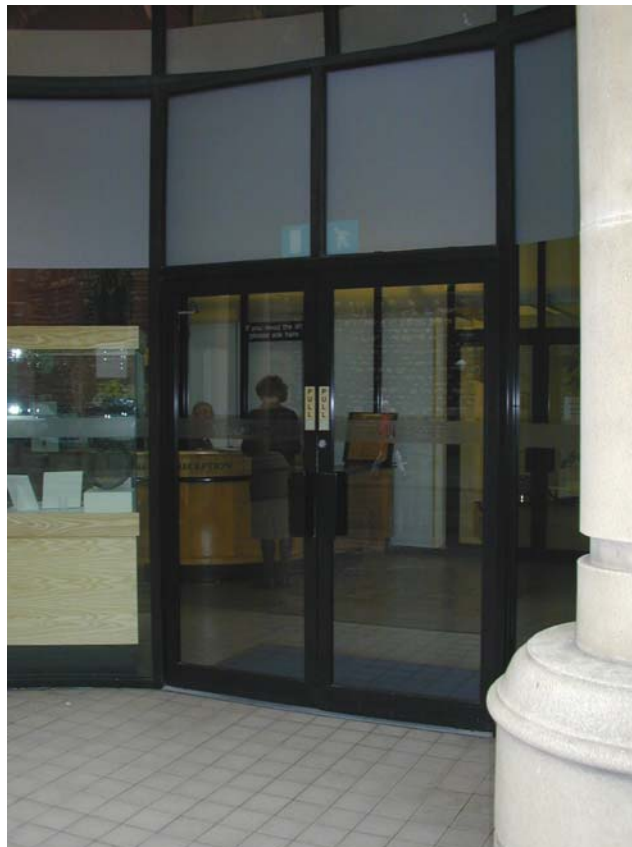
The main entrance is formed as part of a new extension which was constructed during the late 1980's. A level entrance has been provided and the surface of the external element of the entrance area has been constructed using textured ceramic tile. The colour and texture identifies the close proximity of the entrance. The entrance wall itself is fully glazed with an etched band at about 1600mm above floor level. A brown coloured metal framing system has been used, due to the level of lighting internally; the frame was hard to see on the day that the appraisal was carried out.

Access to the main reception area is provided by a pair of doors. The doors are glazed, so there is a clear view of people entering and leaving the building. Unfortunately the door handles are not clearly visible and they are constructed of a cold metal which could be uncomfortable for some people to use. Generally the door handles are suitable for people with limited dexterity. However, the doors themselves are very heavy to open, a pull of more than 50N (Newtons) being required to open the door. Good practice guidance recommends a maximum force of 25N to 30N to open a door.

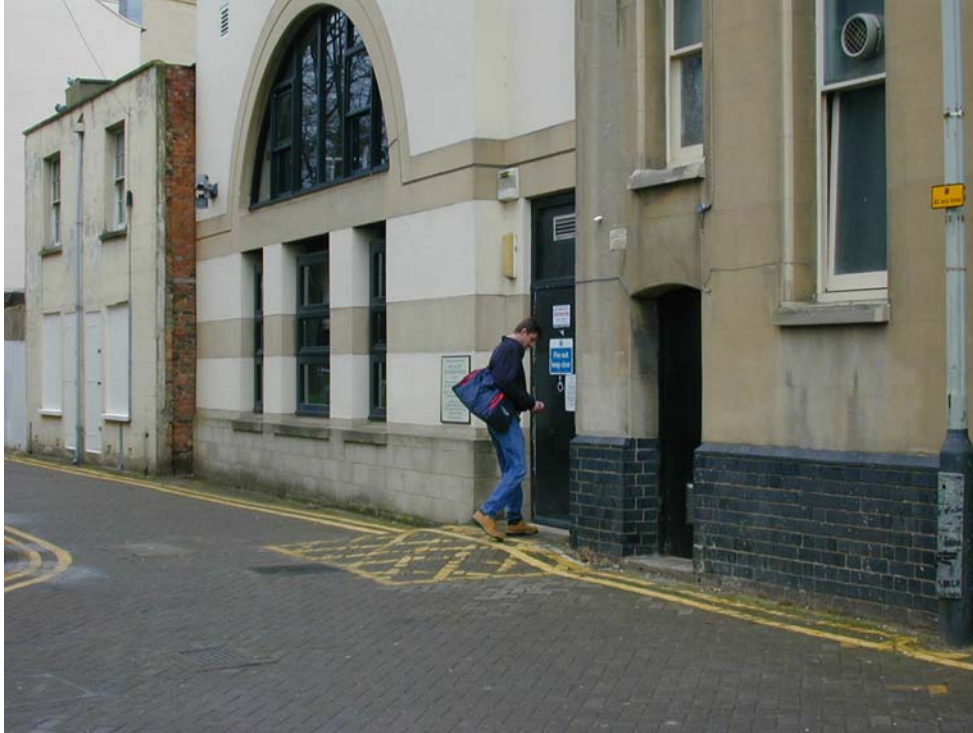
As can be seen the door opens over a raised landing/ramp which has been formed in the roadway. This area has been raised by approximately 110mm which provides a level threshold but also means that the user could potentially have problems moving away from the door and clearly there is a risk from passing traffic.

The door is 900mm wide and has a single door handle at about 1100mm above ground level. The door was not opened therefore no measurement of the opening load or clear opening width could be made.

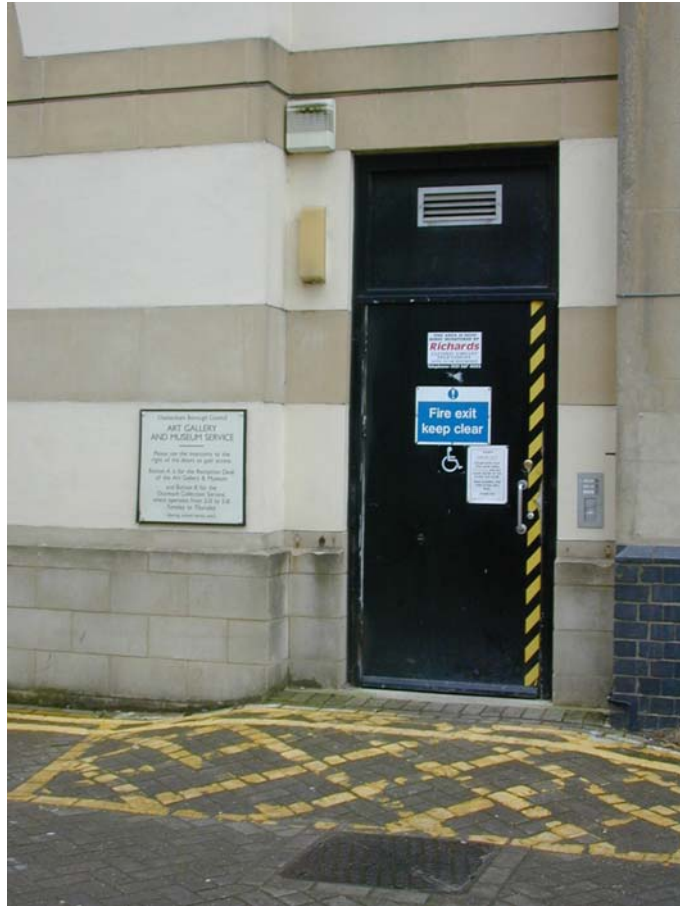
Ramped approach to the rear of the building. Chester Walk.

Controls, which are adjacent to the door at 1100mm above ground level, are provided to call staff from the museum, the library or the Outreach Collection Service. This facility was not tested but it would not be a comfortable system for some users. There is no indication of the facility at the main entrance.

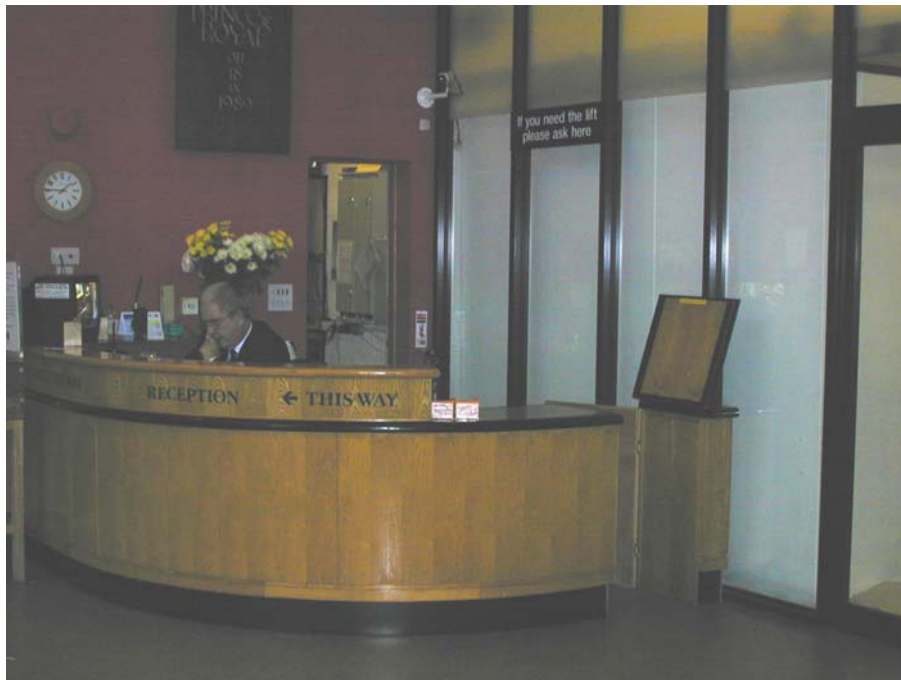
The reception area has a relatively low level of lighting but benefits from the large amount natural light provided by the glazed entrance screen. On the day that the survey was carried out there was no apparent problems with shadows or glare. Although contrast between the entrance area floor and framing is good there is not the same level of contrast within the reception area.

The reception desk does not adequately provide for wheelchair users. The top surface of the desk is 1100mm above floor level with an area reduced to 900mm above floor level, however, there is no provision for people to move close to the desk without banging their knees. Access to the desk from the service side is also not suited to people in wheelchairs. There is no induction loop facility at the reception desk.

Within the reception area there is sufficient space to allow for easy movement and there are resting chairs provided. These chairs have a seating height of 450mm and are not provided with arms.

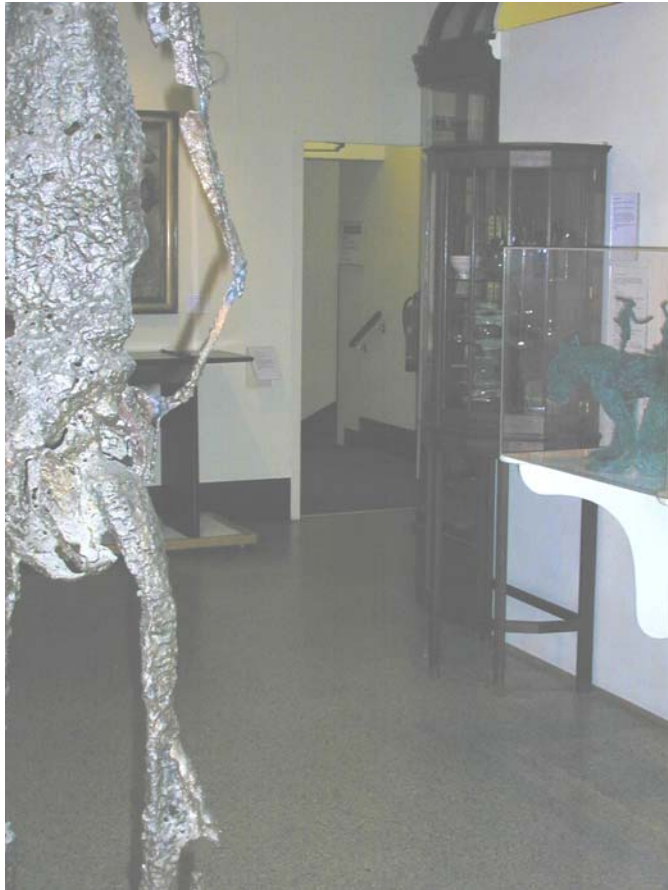
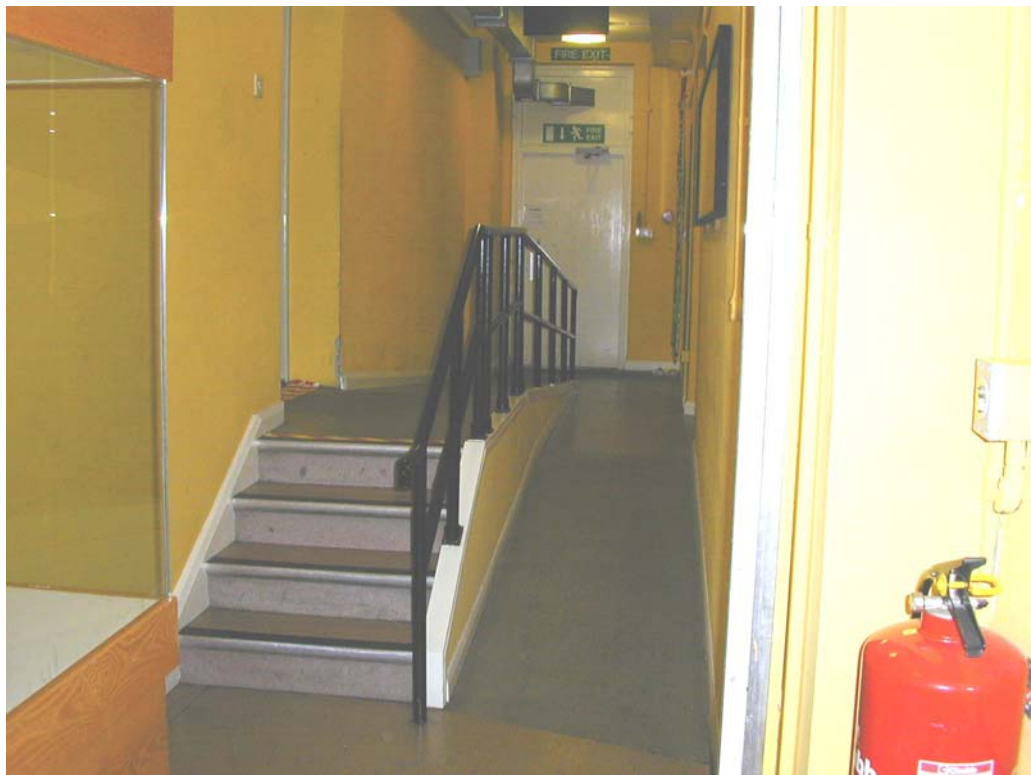
As already stated this service occupies a Victorian building which was extended and refurbished in the 1980's. There are numerous level changes, most are minor and are accommodated within a sloping floor. The sloping element is identified by a colour change in the carpet; there is no tactile warning of the change.

Within the exhibition areas there is adequate room between exhibits to allow for easy movement. Unfortunately some exhibits, because of their design, project into the manoeuvring area. This could be a problem for some people with limited vision.

Access from the rear door to the reception area and other areas of the building is provided by a system of ramps. These ramps are 850mm wide but with a very limited turning area at the landing, this has caused problems for some users.

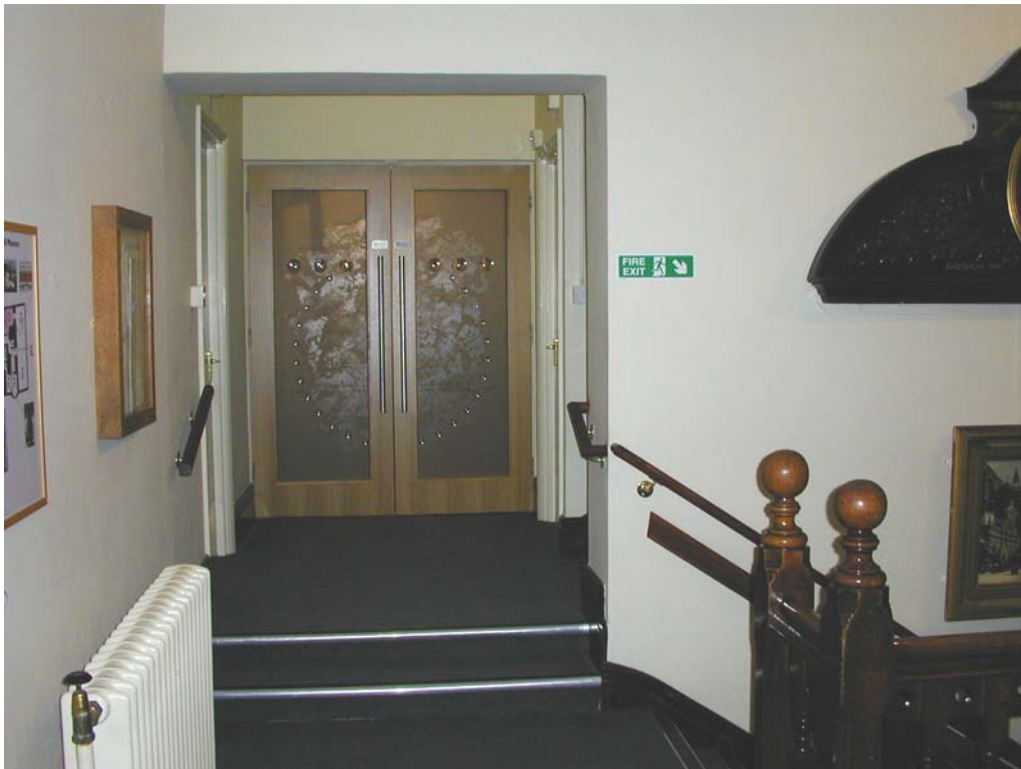
Door ways within the building are generally on magnetic hold open devices and provide adequate room for manoeuvre. The door way to the café is hard to open but is fitted with vision panels. A meeting room is provided at first floor level and the door to this facility is heavy to open and does not have a vision panel. Some doorways do not have vision panels, although these are in the minority. The example below is substantially glazed but with opaque glass, however, this doorway is of special interest and is an art exhibit within the building.

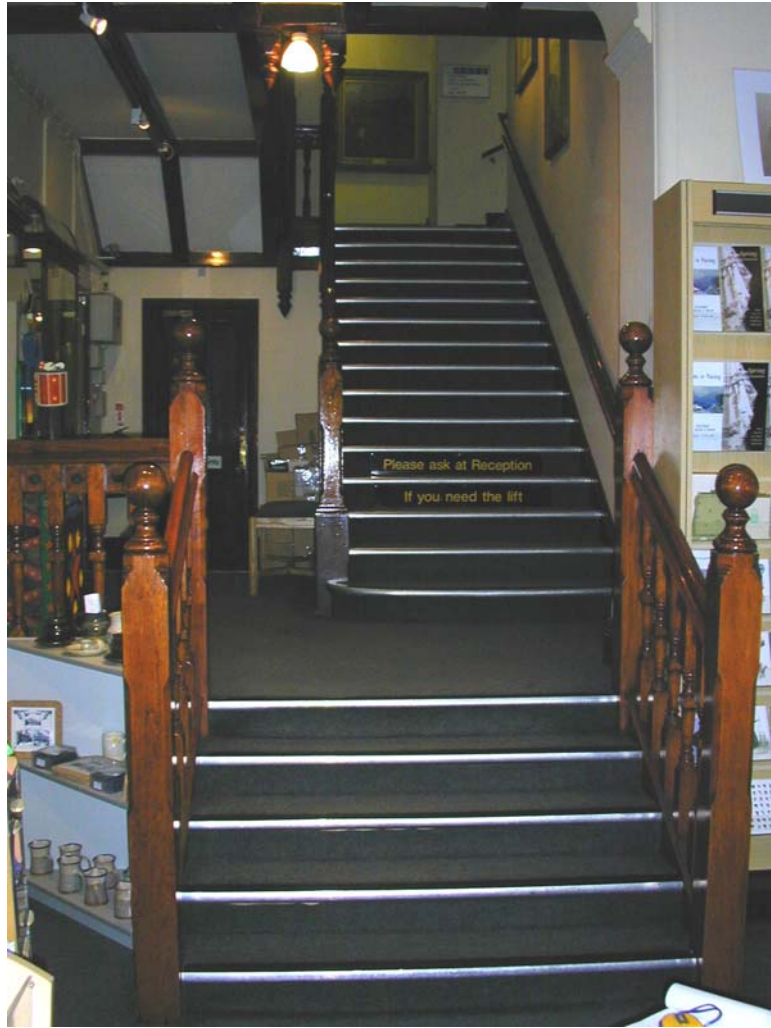
Within the building there are various flights of stair, these are original units and have a rise of 175mm with a going of 280mm. Wooden handrails are provided to both sides of the stair which is 1400mm wide, the handrail being 800mm above the nosing level. Smaller flights have the following dimensions rise 140mm, going 280mm and the stair being 900mm wide. The stairs are all carpeted in the same floor covering as used on the floor, however, the nosing is identified with plastic fittings.

The stairs are a feature of the building but they do present an obstacle to people moving around the building. The decoration of this element of the building will mean that some people may have problems identifying the stair, however, there are sufficient visual and tactile queues to assist most people to avoid the problem.

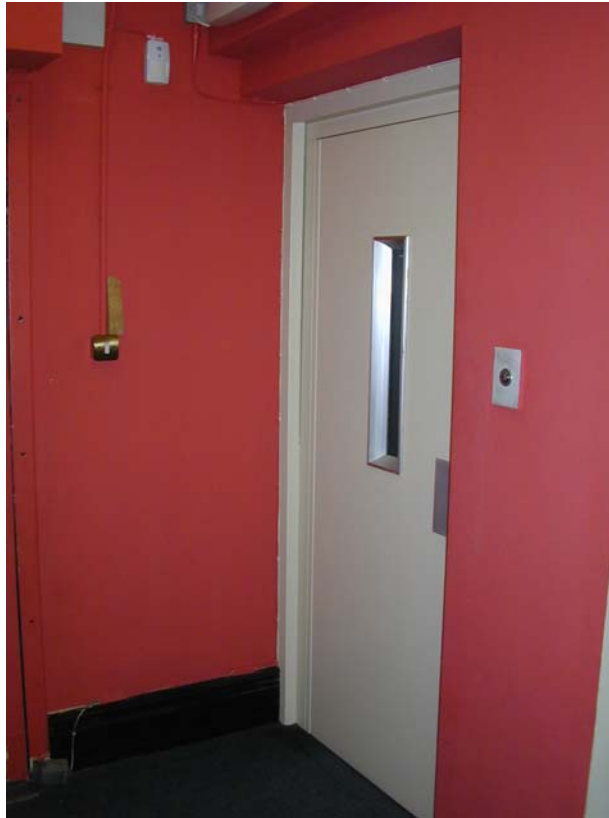
The lift is the only means by which people with extreme limitations to their movement can obtain access to the upper floors. The lift is very old and does not follow the design suggestions in BS 8300. The car is 860mm wide and 1580mm long.

The lift is not available for independent use by any visitor to the museum and so some of the limitations of the units design are reduced. Signage to the facility is also not good but the way that the service is provided also reduces the impact of this problem.

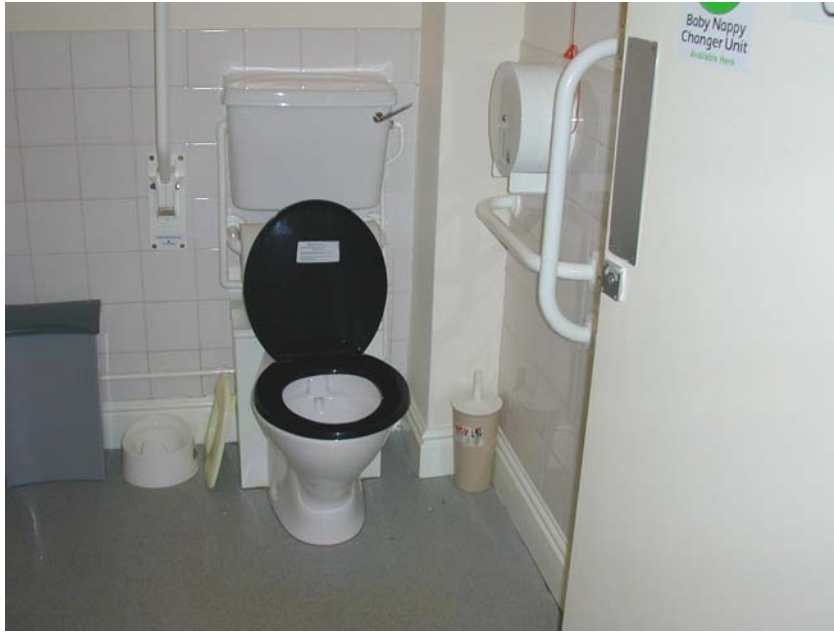
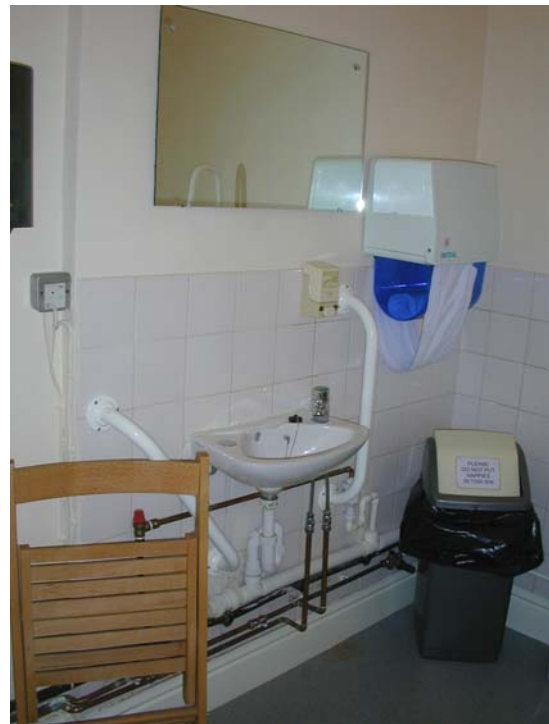
An accessible toilet has been provided at first floor level but this facility also suffers from being old and poorly designed, particularly with regard to the detailing of the room. The doorway is inward opening; the coat hook is too high to be used from a seated position; the mirror is 1400mm above floor level and washbasin is too high above the floor level at 830mm. There was no colour contrast which could be a problem for people with limited eyesight.

On the day that I visited the facility, work was in progress to box in some of the plumbing fittings. However, the room did not appear to be suitable for use as an accessible WC.

Signage to this facility is also poor, route maps are not clear and would be hard for some people to see and comprehend.
