RESTORATION OF CHELTENHAM WAR MEMORIAL

Condition survey and conservation options appraisal

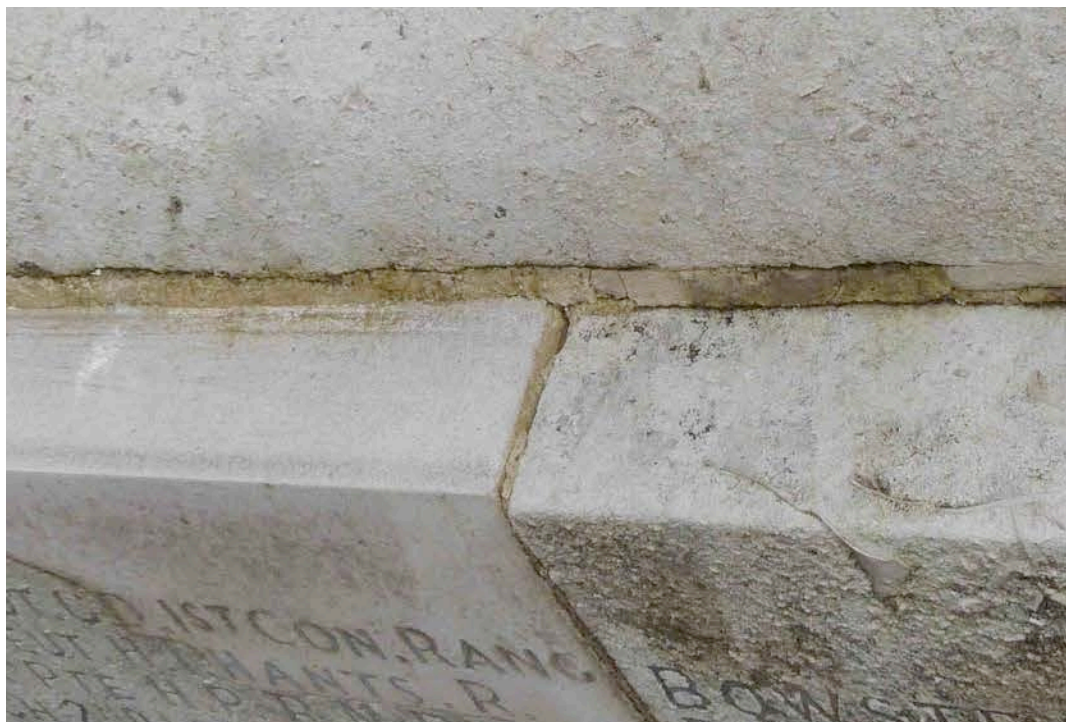
- The west ends of both of the smaller inscription panels have moved slightly in relation to the plinth beneath. Measurement suggests a movement of 3 - 5mm outwards for each of the panels. This is despite (and perhaps because of) the dowels between these panels and the plinth. The result of this movement is shown in the small dislocation at the edge of the central inscription panels on the north and south sides (Fig 8).

Fig 8: small dislocation between central panel on south side and adjacent stone

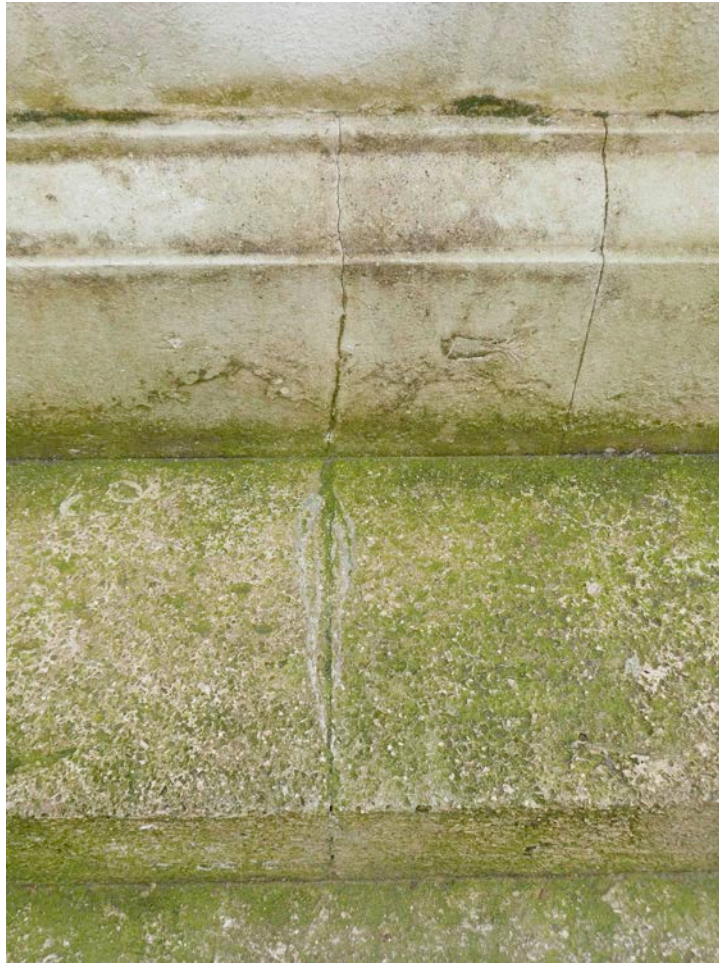
- The central plinth stone on the west side has a vertical crack running immediately above the joint in the top step beneath (Fig 9). This suggests that there has been some minor settlement. The crack is not recent and does not appear to be developing.

Fig 9: crack in moulded base plinth stone immediately above joint in step

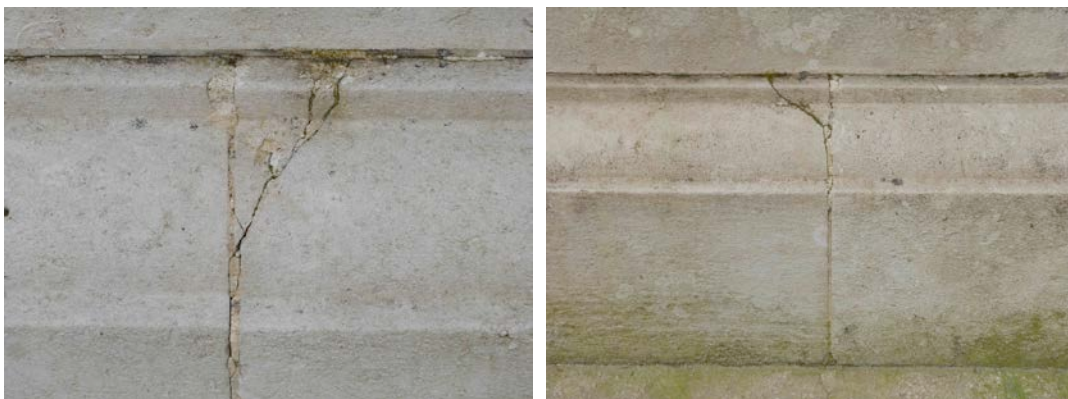
- On the north, east and south sides, there are slight spalls of stone adjacent to joints in the plinth (Figs 10 and 11). These are due to tensions that have built up due to corrosion and expansion of the cramps across the joints of the plinth.

Fig 10 and 11: spalling of base plinth stone due to corrosion of cramps (south and north elevations)

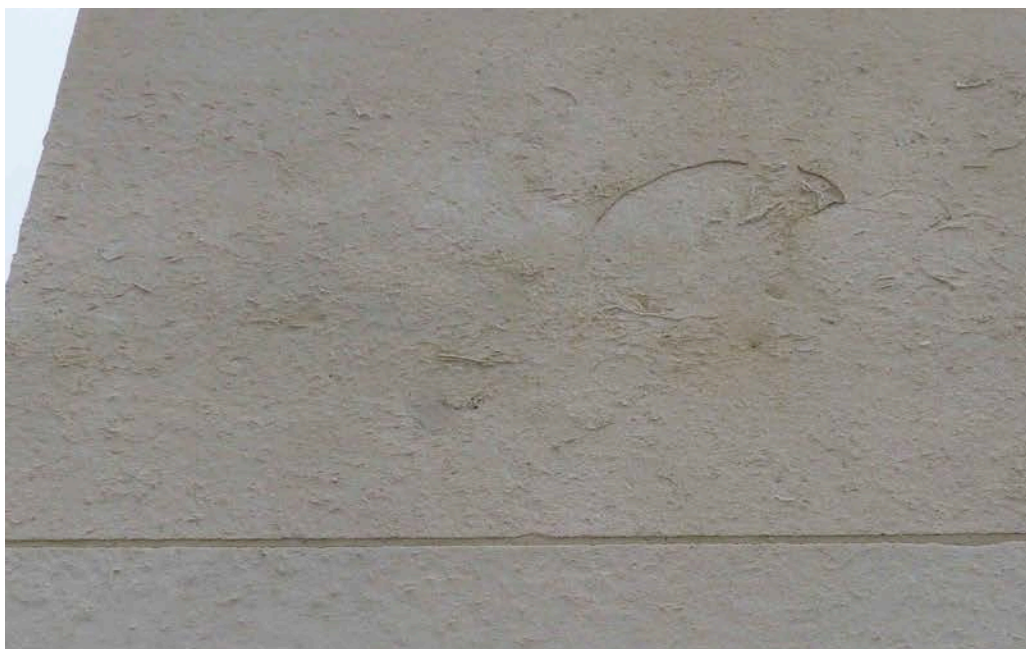
The stone on the memorial is generally of good quality with variable shell content. As shells do not tend to erode, they are a good indication of the degree of general erosion (Fig 12). On sections exposed to weathering (for example the horizontal (sky-facing) part of the moulding), the erosion is at least 3mm.

Fig 12: detail of obelisk stone showing how shells (which do not erode) stand proud of adjacent eroded stonework

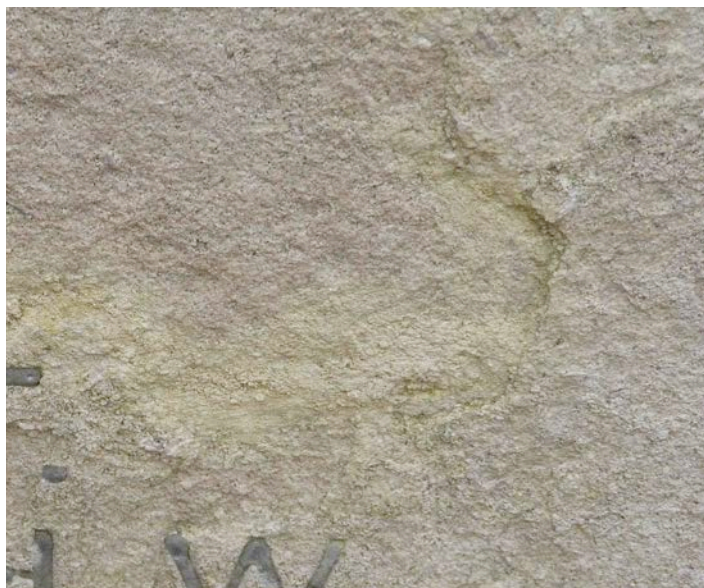
Fig 13: stonework on east side panel showing deterioration through clay swelling

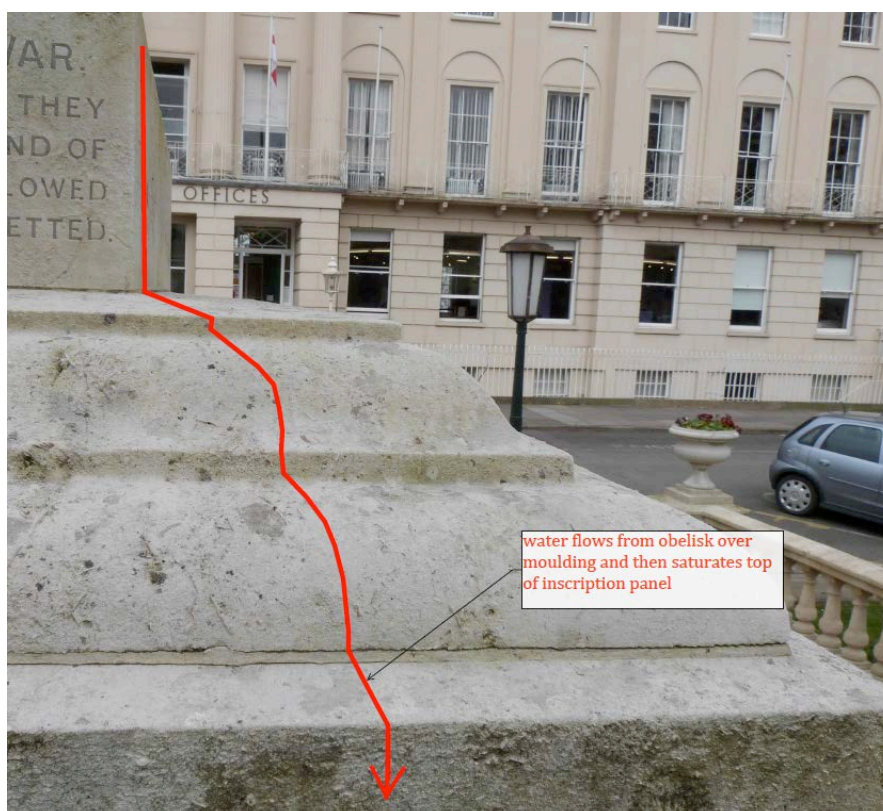
- Corrosion of cramps used in the construction of the memorial
- Original design of the memorial (Fig 14) which means that certain parts of the stonework remain saturated; this makes them susceptible to freeze/thaw cycles and microbiological growth within the stone.

Fig 14: original design leading to saturation of inscription panel

- **Design.** The interaction of water with stone is key to understanding decay processes. In the case of the memorial, there is a fundamental design flaw that allows rainwater to run down from the obelisk and moulding and to saturate the upper parts of the inscription panels. This, along with the presence of nutrients from adjacent trees (that collect on horizontal surfaces) means that conditions are perfect for the colonisation of the pores of the stone by algae and other microbiological growth. In the normal course of events, this might not be a problem but, in this case, the growth of the algae obscures the inscriptions which are the most significant part of the memorial.

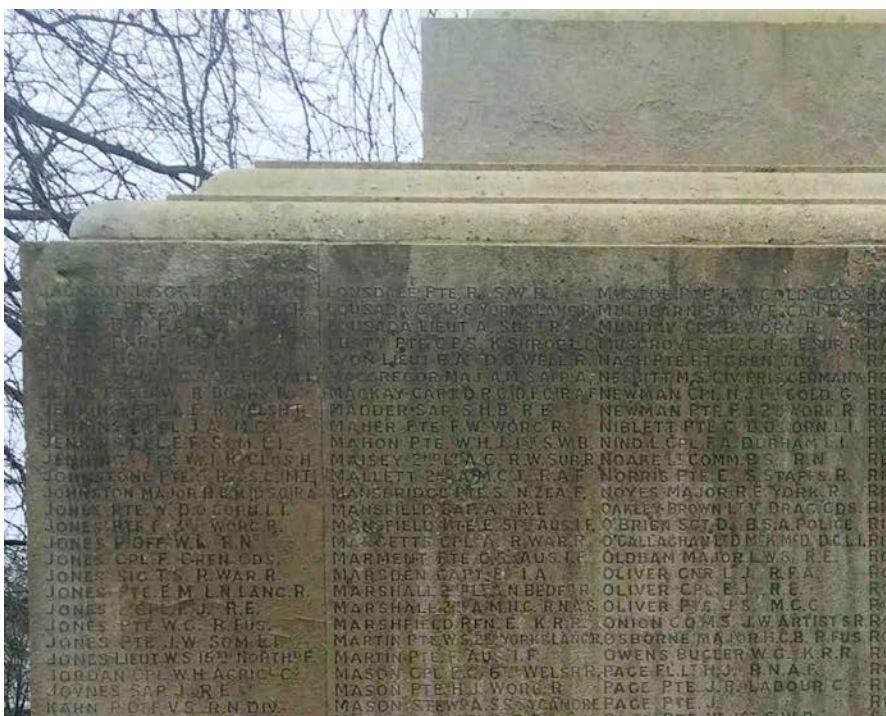
Fig 15: detail of north side inscription panel showing algae growth and how it obscures inscription

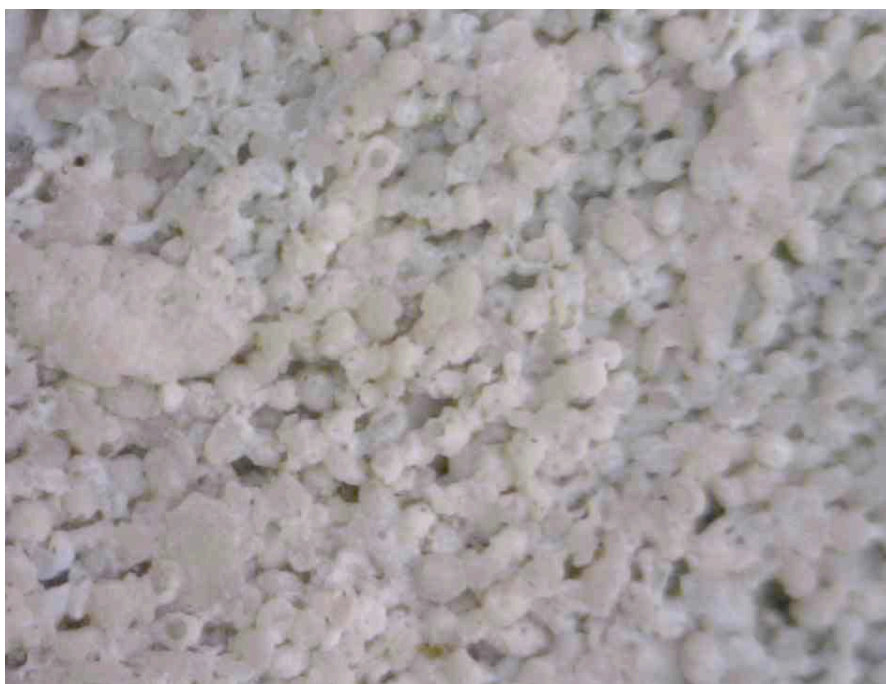
- Repeated cleaning of the memorial which has caused accelerated erosion and opened up the pores of the stone (Fig 16); this in turn encourages further microbiological growth (Fig 17).

Fig 16: detail of stone (x50 magnification) showing how cleaning has opened up the surface pores of the stone

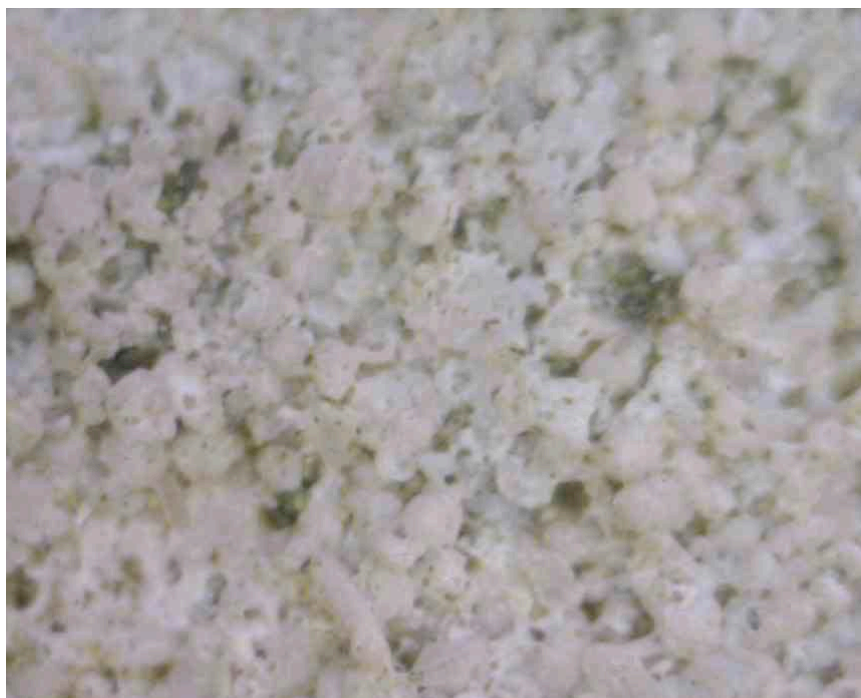
Fig 17: detail from north inscription panel showing how microbiological growth (green) has colonized deep within the pores of the stone

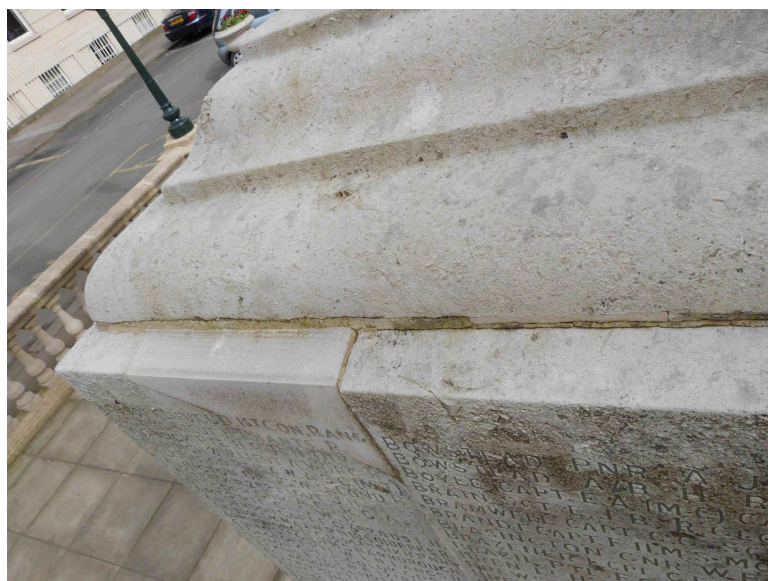
Fig 19: detail of moulding showing cracked pointing

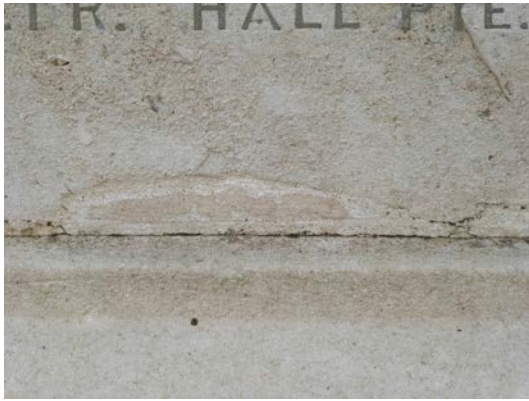
The condition of the plinth is generally good although there is some cracking of vertical pointing as well as the spalls in the stone adjacent to the joint (see 'Structure'). The inscription panel also has a repaired spall at the base (Fig 19). The stone of the inscription panel is generally sound but there is some algal staining and more general erosion at high level. The mortar joints are intact although there is some cracking and disruption in the vertical joint with the west elevation inscription panel. There are two indents in the return of the west elevation inscription panel and one in the corresponding stone on the east side.

Fig 20: repair at base of inscription panel

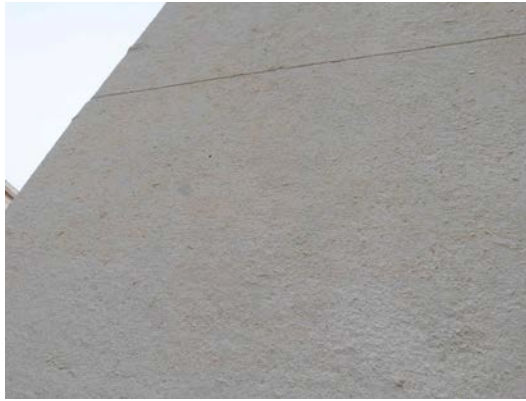
The obelisk stones are generally sound with overall erosion of about 1 – 2mm; the evenness of the surface suggests that the surface may have been tooled off. This is supported by tool marks still visible on the third stone from the bottom (Fig 21) as well as a slight irregularity in the arris which does not have the precision that might be expected from the original masonry. The lowest stone has some slight surface deterioration and there is a very fine crack/shake in the stone just to the east of centre.

Fig 21: vertical tool marks on obelisk stone

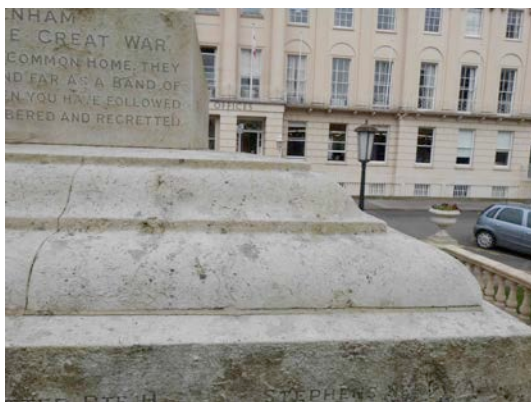
The horizontal joint between the inscription panel and the moulding has previously been repointed but is now cracked (Fig 23). The moulding itself has two vertical joints; the mortar in both of these is cracked. The stone itself has general erosion but also a number of more localised cavities (Fig 24).

Fig 23: cracked pointing at base of moulding

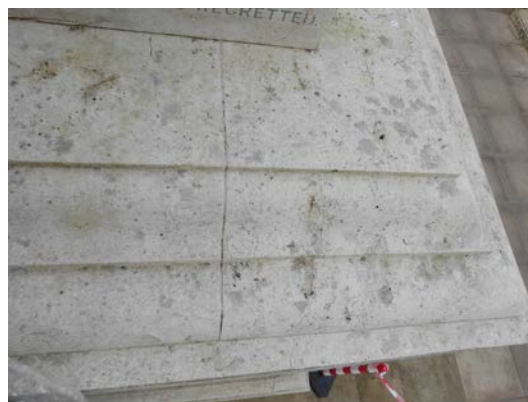
Fig 24: erosion of sky face of moulding

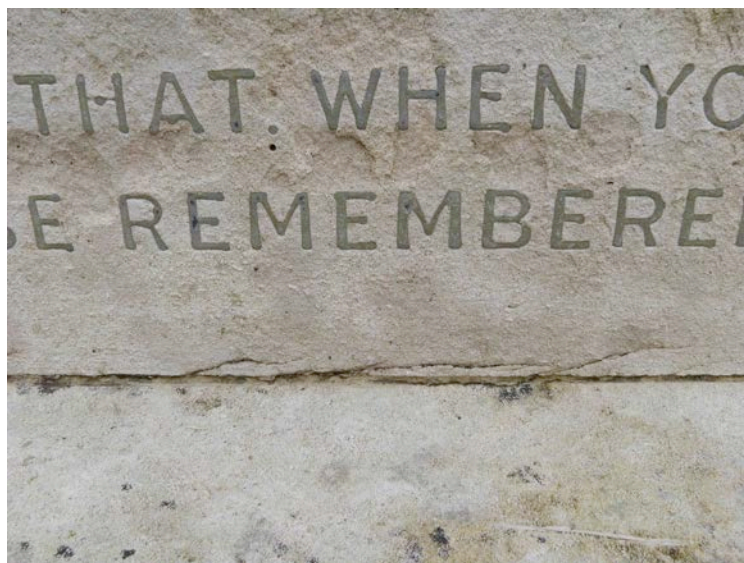
The obelisk plinth stone, which contains an inscription, is quite eroded. The joint at the bottom of the stone is cracked and there are a number of minor cracks in the stone immediately above the joint (Fig 25). This seems likely to be due to thermal tensions arising from the very fine hard cement joint.

Fig 25: cracks in stone adjacent to joint

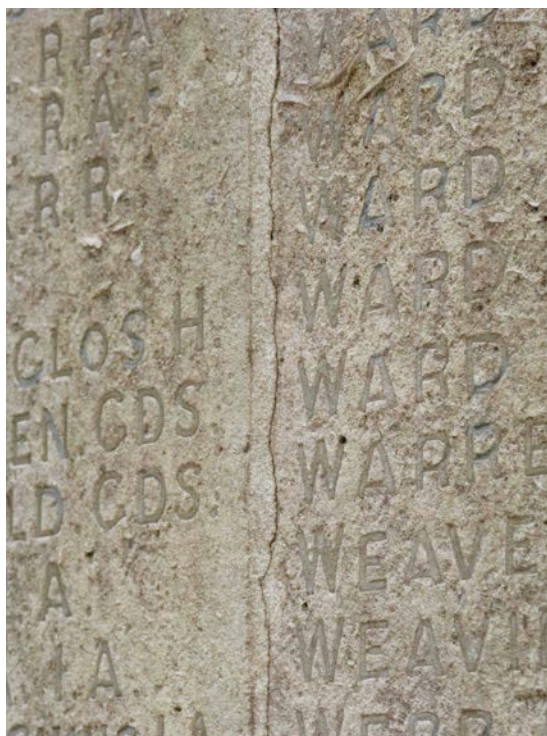
The inscription panel is perhaps less eroded than on other sides. However, as this is north facing, it receives less sunlight and therefore remains wetter. This has allowed for more microbiological growth to become established. The eastern vertical joint is slightly cracked but the stones are flush. At the western vertical joint, there is a displacement of 2-3 mm between the two stones and the pointing in the joint is cracked (Fig 30).

Fig 30: detail of vertical joint of inscription panel showing slight displacement and cracked pointing

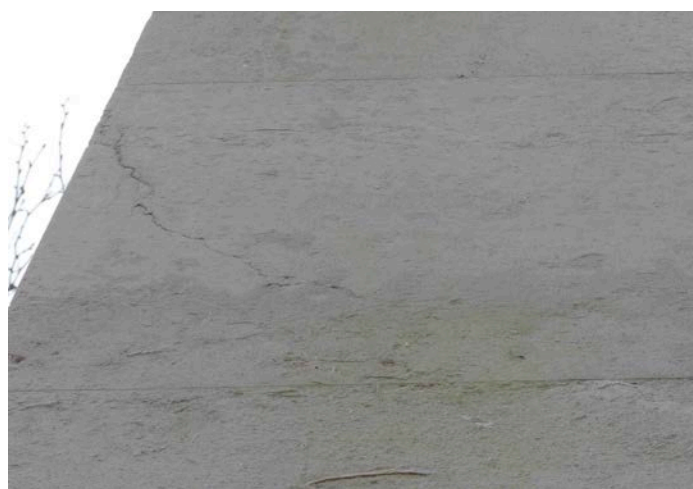
The north faces of the obelisk stones are generally sound but there is a noticeable increase in the amount of microbiological growth compared with other sides. There are a number of visible geological faults in the stone; the stone second from the bottom has a number of vertical natural fissures and the middle stone has a diagonal fault (Fig 31). The pointing between the stones appears sound.

Fig 31: natural fault in obelisk stone

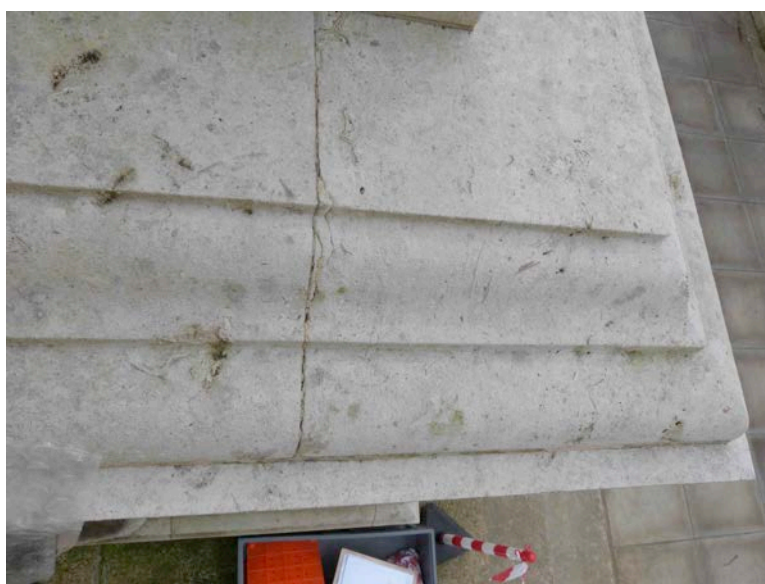
The horizontal joint at the top of the inscription panel has been repointed but the mortar is now cracked. The moulding has general and localised erosion but is in sound condition overall. The vertical joints have previously been repointed but are now cracked (Fig 34) and there are some associated parallel cracks in the adjacent stone. The obelisk plinth is sound with some microbiological growth. The horizontal joint with the moulding is mostly intact but there are some cracks in the adjacent stone (Fig 35).

Fig 34: detail of moulding showing cracked joints

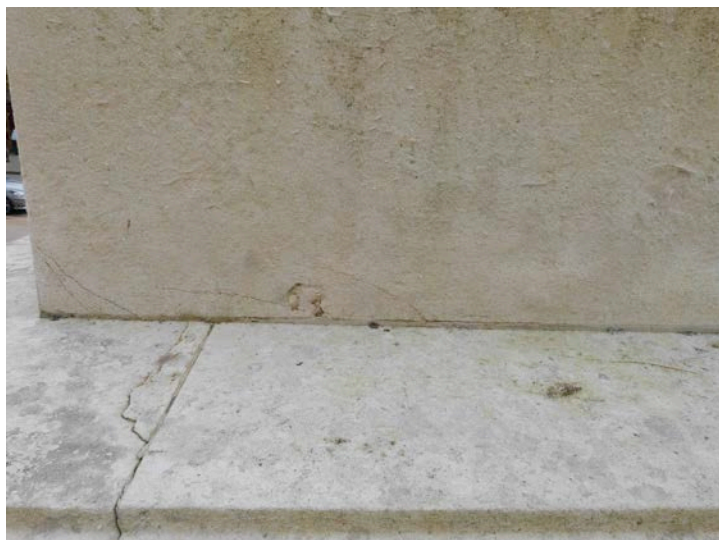
Fig 35: detail of moulding and obelisk plinth showing cracks in stone

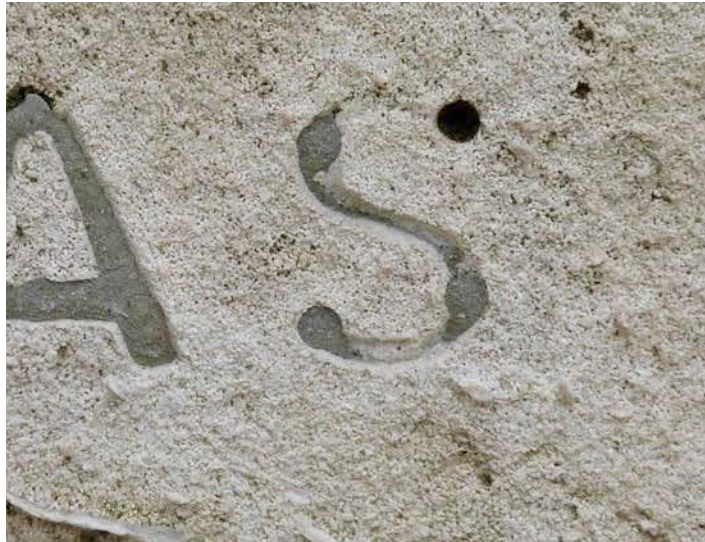
Fig 38: detail of mortar fill missing from incision

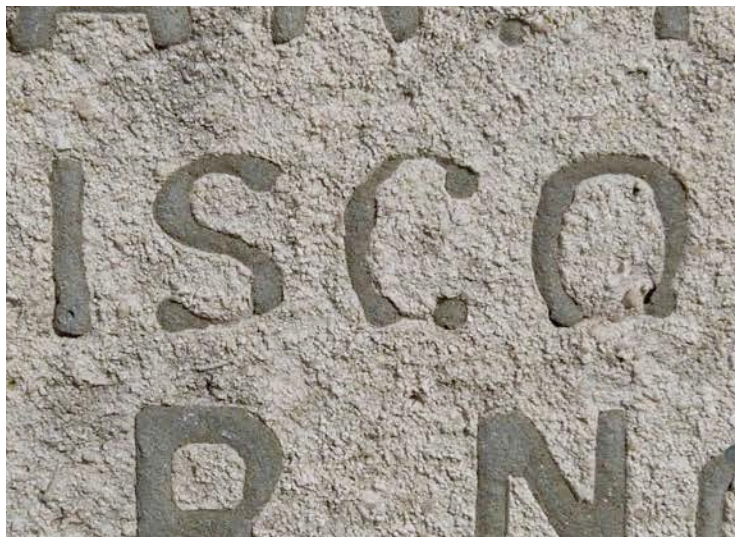
Fig 39: detail showing erosion of both incision and mortar fill

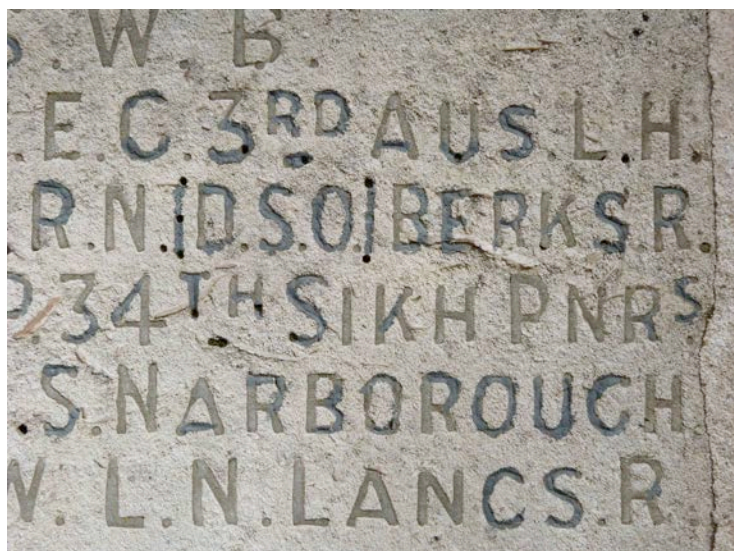
Over the years, there have been a number of attempts to improve the legibility of the lettering. This mostly has been carried out by using grey paint to fill areas of missing or fading mortar fill (Fig 40). However the erosion of the surface has meant that introducing a sharp precise line with paint has been impossible (Fig 41).

Fig 40: typical example of repainting

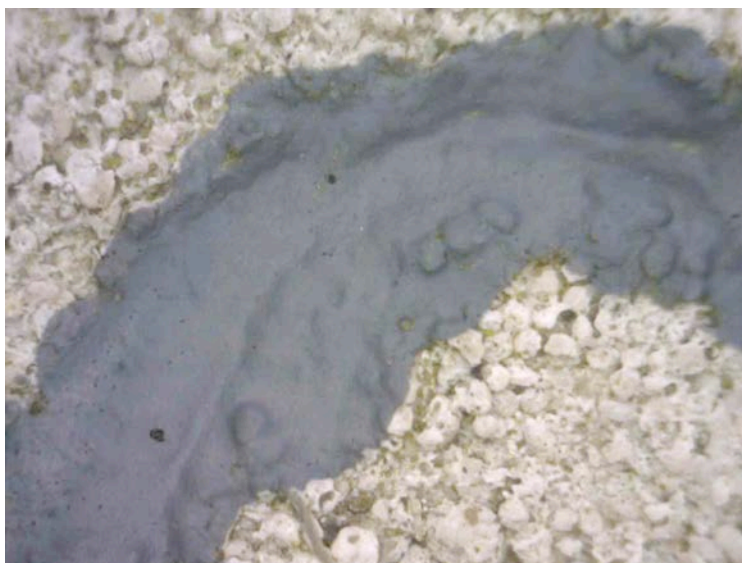
Fig 41: detail of repainted lettering (x50 magnification) showing inaccuracy of line compared to precision of original (see Fig 36)

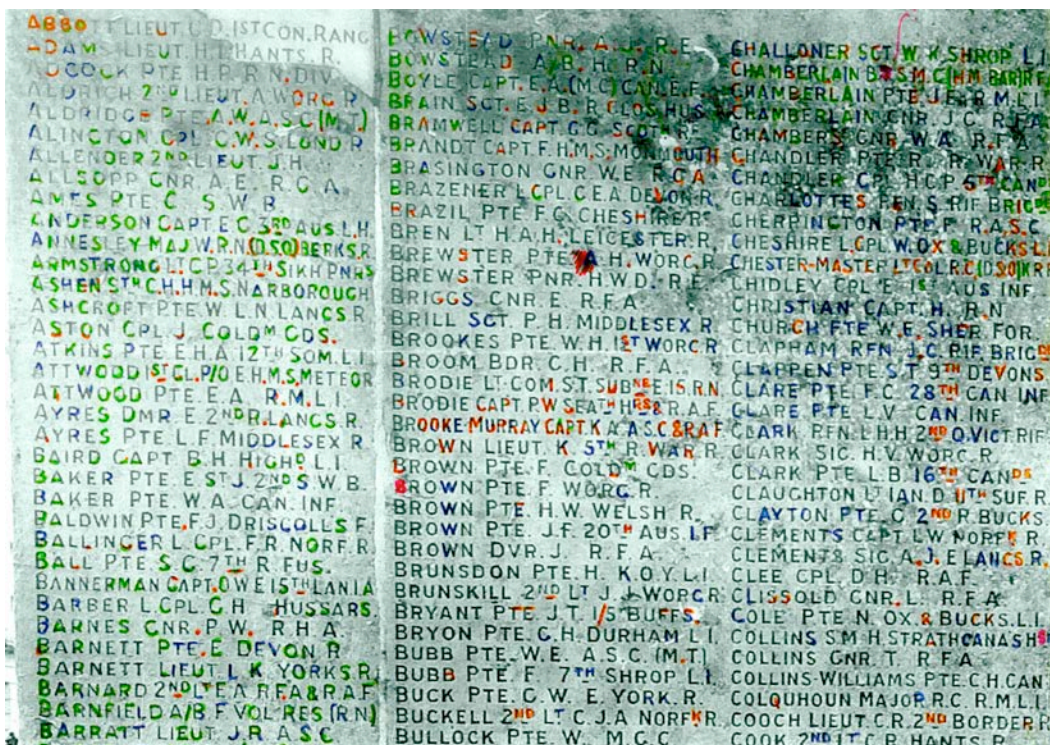
This is exposed to the prevailing weather and therefore would be expected to suffer from increased erosion compared to the more protected east and north sides. It appears that the upper section of the stonework (where the lettering is generally obscured by algae and other microbiological growth) has quite extensive areas of re-painting and, towards the east side, there are more areas of faded incisions. The lower west quadrant is in better condition but the lower east quadrant has some localised areas where the infill is missing; this may be due to variations in the stone or excessive cleaning near the corner.

Fig 42: upper west quadrant of south inscription panel
