## B. J. UNWIN FORESTRY CONSULTANCY

24<sup>th</sup> Oct 2017 - BJU/mmi

1 Hazebrouck Close,  
Cheltenham, GL51 3QA.  
Mobile: 07960 814364 Email: [matthew.c.fing@hotmail.com](mailto:matthew.c.fing@hotmail.com)

### OAK Tree inspection @ No.1 Hazebrouck Close.

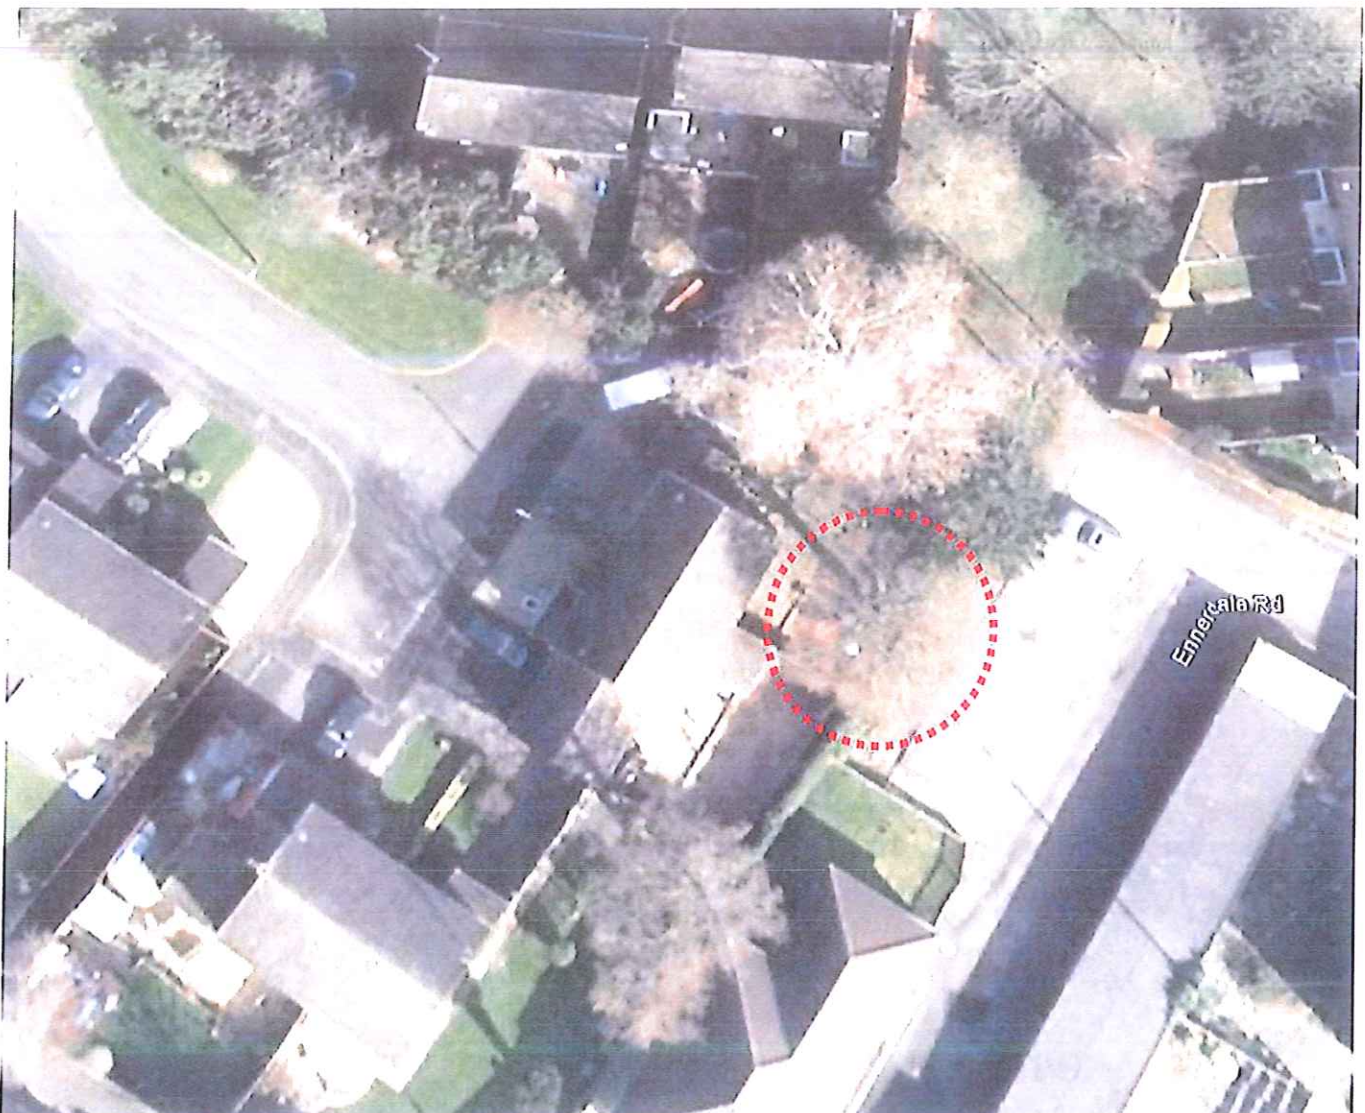
- 3.1 The site inspected is a small domestic plot, on a 1970s residential estate. The front garden is mostly paved parking. The property's outdoor amenity space is the rear garden south east of the house, about 8.5m deep from rear of house to rear boundary fence, by about 13m wide. The rear garden extends along the northern end of the house as yarding and garden sheds.
- 3.2 The site is low-lying. The whole plot appears adequately drained, but a ditch runs just outside the northern boundary of the plot.
- 3.3 Solid geology from BGS website: Charmouth Mudstone Formation - Mudstone. Sedimentary Bedrock formed approximately 183 to 199 million years ago in the Jurassic Period. Local environment previously dominated by shallow seas. Superficial deposits: None recorded
- 3.4 Google Earth 2007 aerial below. Oak tree marked. It has grown since.

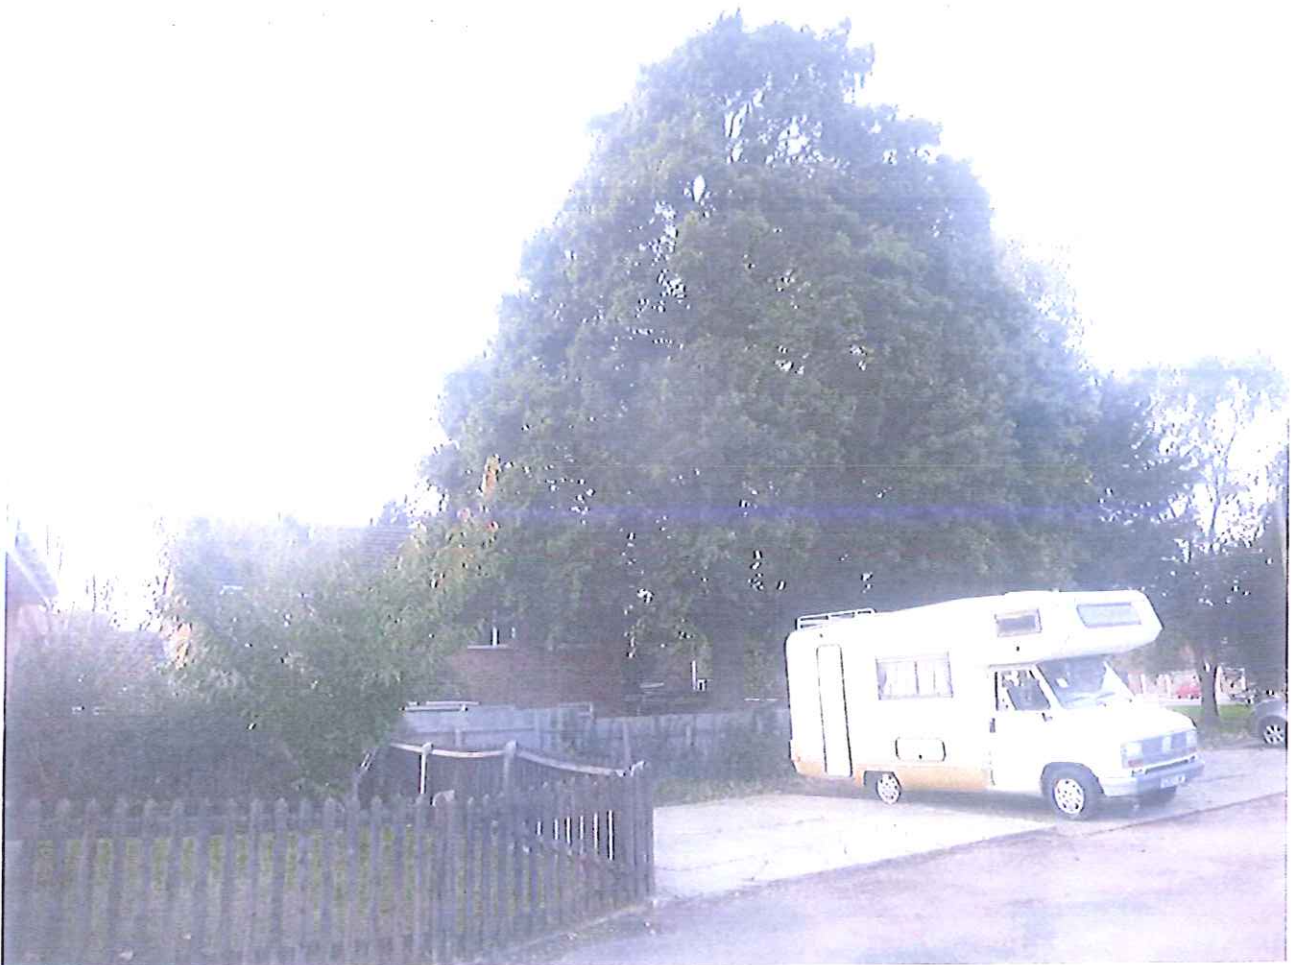
- 4.1 The oak in the middle of No.1's small rear garden is a sessile oak (*Quercus petraea*), which is the western native oak. Stem diameter (DBH) is about 70cm. The oak is 15m tall, with a well-shaped and very dense canopy.
- 4.2 Radial spread is 4.7m north east (where it over-sails a yew canopy), 7.1m south east (5m over the rear boundary), 6.7m south west (2m over the side boundary), and 6.4m north west (where it reaches the house).
- 4.3 View of the oak from the south in photo below. Bedroom windows of No.1 just visible level with base of oak canopy. Note the dense and broad-columnar canopy.

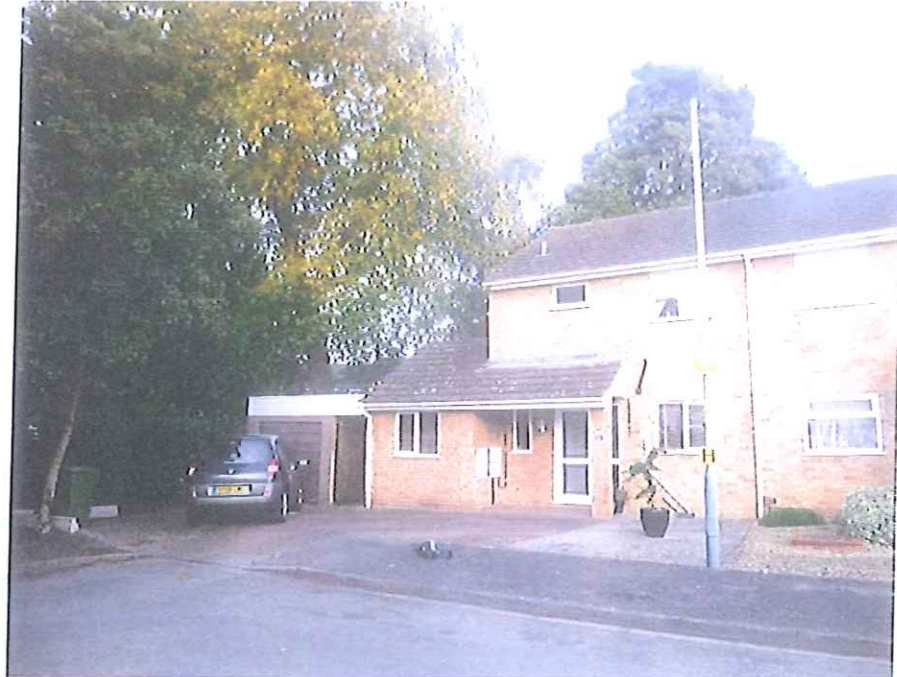
- 5.1 The oak stands near the middle of a small rear garden which is the only outdoor amenity space for the property. The photo below shows the exposed and public front garden area, which is unsuitable for use other than parking. (Oak tree rear right.)

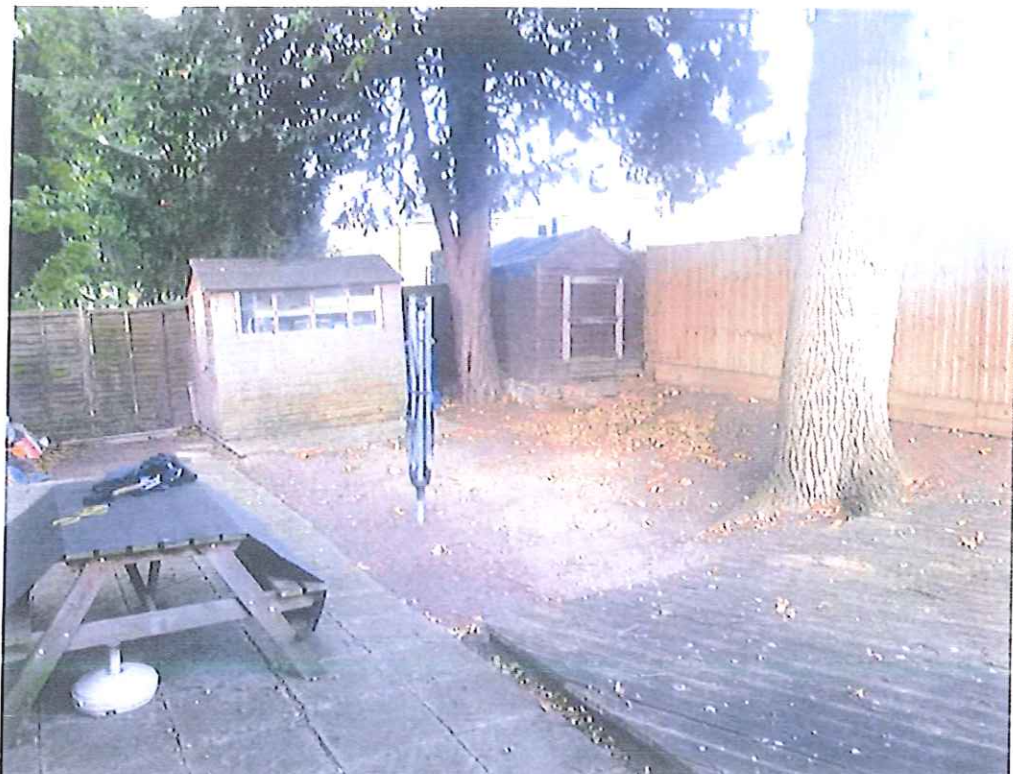
- 5.2.1 Photo north east, below, shows bare rear garden on an early-autumn day. Note absence of vegetation, I believe caused by shading and roots drying soil, from the oak (on right) and to a lesser extent by the yew (centre).

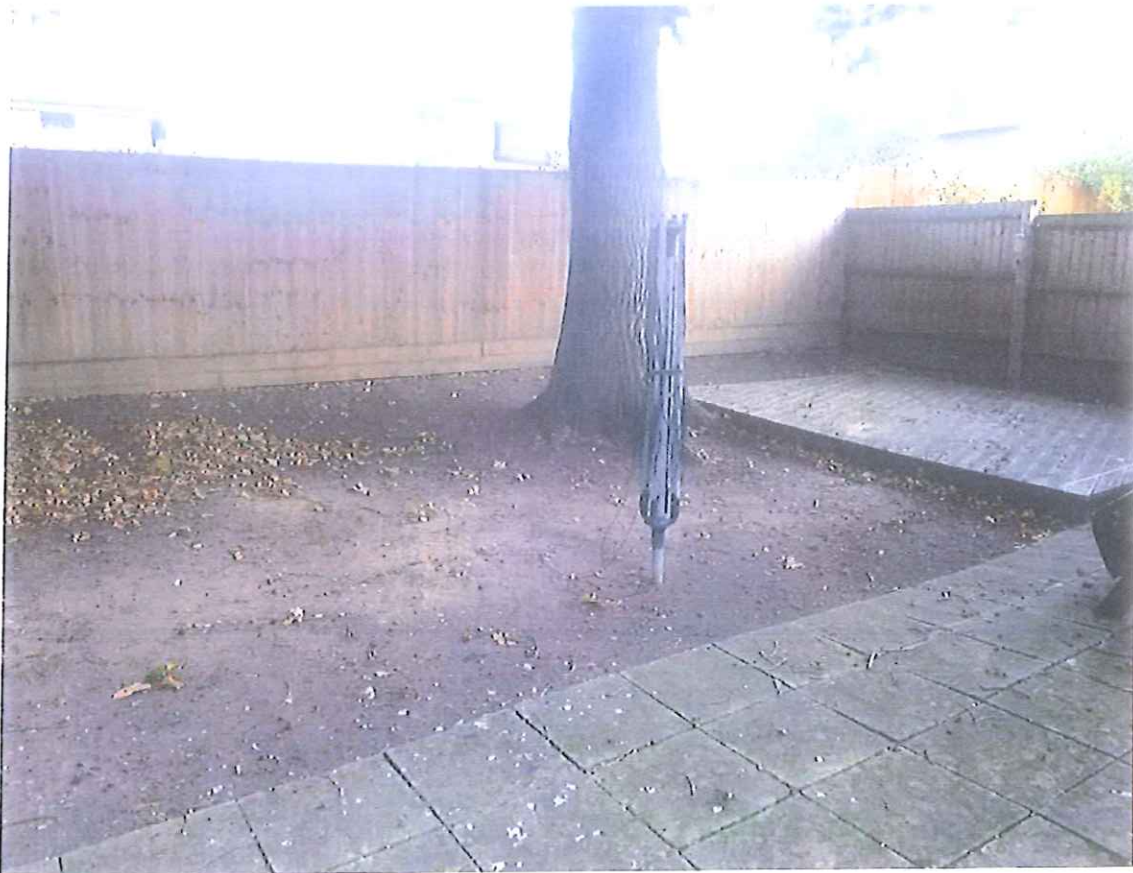
5.2.2

View south showing lack of vegetation. Oak centre.

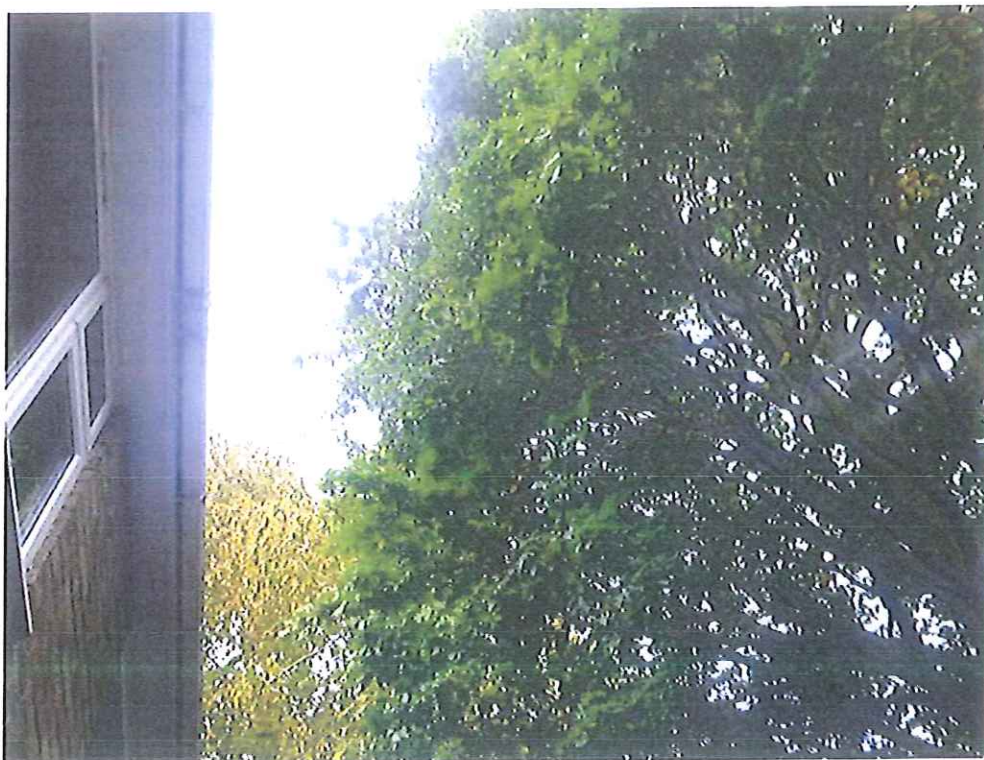
5.2.3 View upwards along rear of house to the oak's dense canopy.

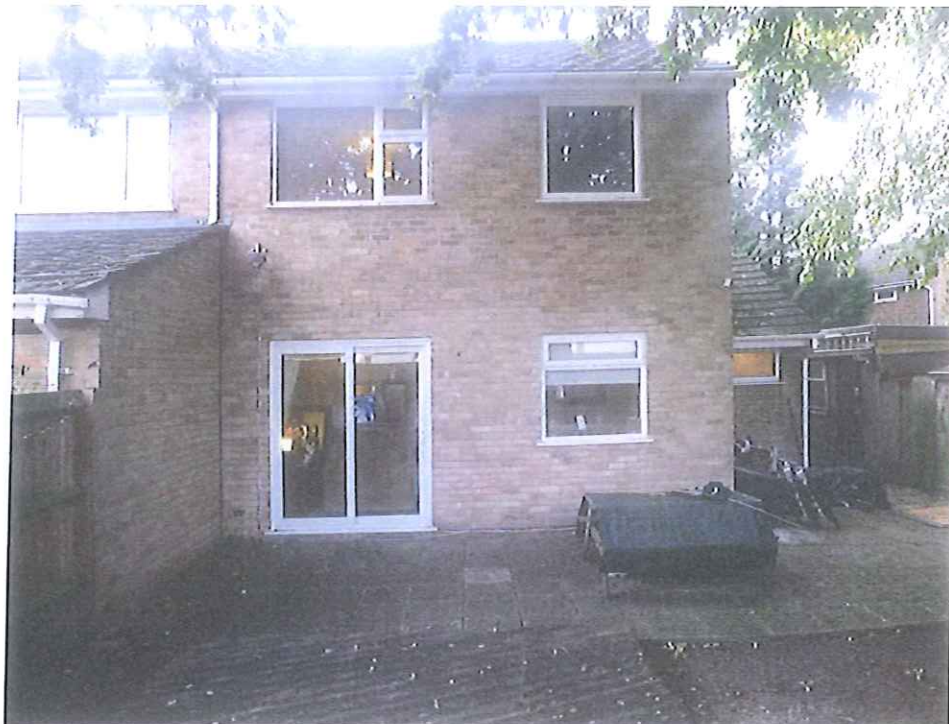
- 5.2.4 View north west to rear of house in late afternoon, note lights in living room and bedroom / landing above, due to shading from the oak canopy, across top of picture.

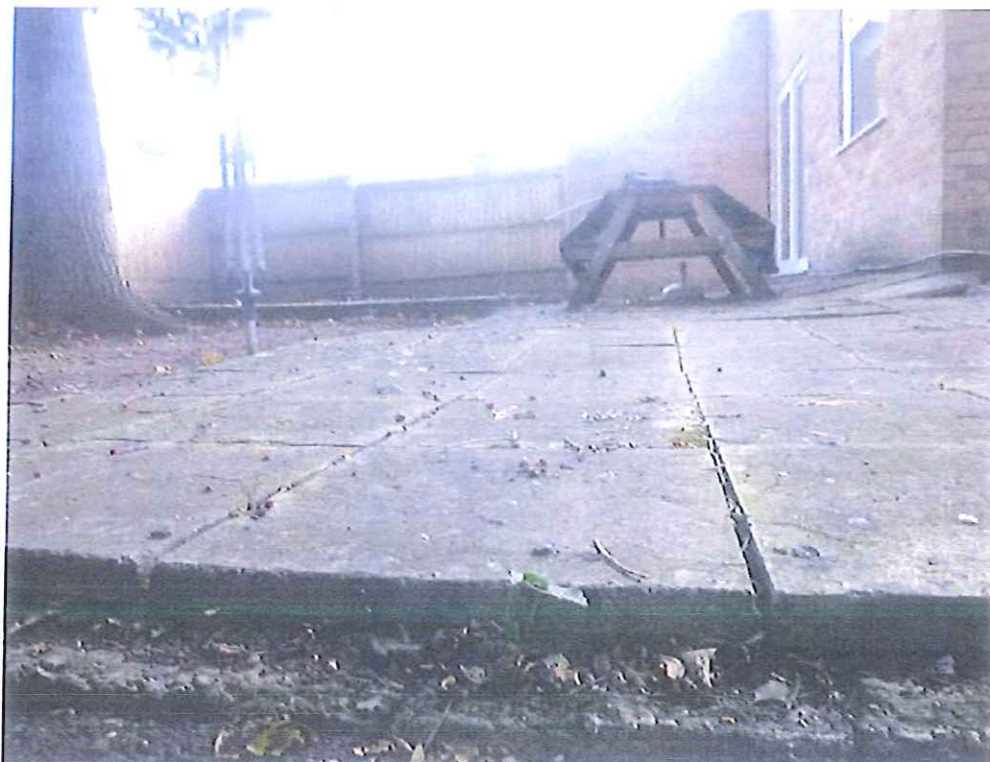
- 5.3.1 The local geology is mudstone, producing clay and silt-sized particles at foundation depth, which can change volume depending on moisture content. Although there is no evidence of cracking in the house structure, there is ample evidence of oak roots desiccating subsoil to cause settlement of rear-garden patio. See in profile below. Note original paving level on right by house.

- 5.5.1 There is no option to retain the oak as it is, so crown pruning or tree removal are the possible options:-
- 5.5.2 Crown lifting:- This would have to be excessive (at least to half tree height) to improve light conditions under the tree, leaving a 'lollipop tree', with much-reduced amenity value.

- 5.5.3 Crown reduction & / or thinning:- Given the health of the tree, any crown reduction with or without thinning would be mitigated by rapid regrowth. Further, any pruning sufficient to give a longer return period would involve high pollarding with 'skeletonising' of the canopy. This would remove the tree's amenity value.

- 5.5.4 Removal:- The oak has a smaller but well-shaped yew 6.7m to its north, a large plane tree stands a little further north, and a mixed belt of trees and hedging runs north west from No.1. North of the large plane is a small area of public open space containing several trees, some of similar size to the oak. Therefore, removal of the oak would not completely denude local tree cover.

- 5.5.5 The impact on local amenity value of oak-tree removal would not be great, because the public area closest to the tree is parking at the end of Ennerdale Road, which appears not to have intensive use. The oak could be replaced by a more-suitable tree planted near the south-east corner of No.1's rear garden, such as an ornamental rowan, a fruiting pear on a Quince A rootstock, or fruit tree such as an apple fruit tree on a vigorous M25 rootstock.
