Pittville Pump Room (22/00340/LBC)

Various repair works [the installation of a steel plate arrangement in order to secure a rotten double beam and the making good of the underside of the roof over the colonnade].

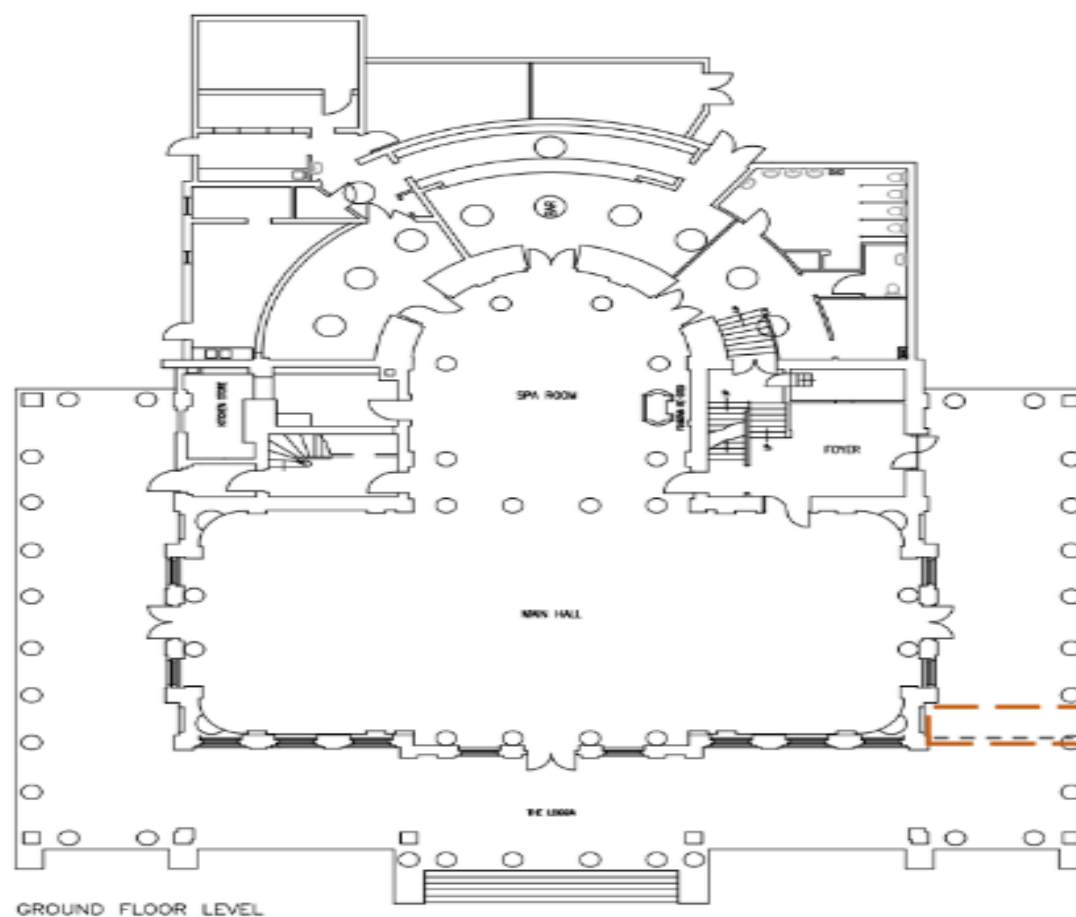
Supporting photograph and plan to show location of timber repair

Area to be opened up for inspection by Clarke Nichols Marcel
- hatched area in drawing 01.

Double Timber beam location for repairs.

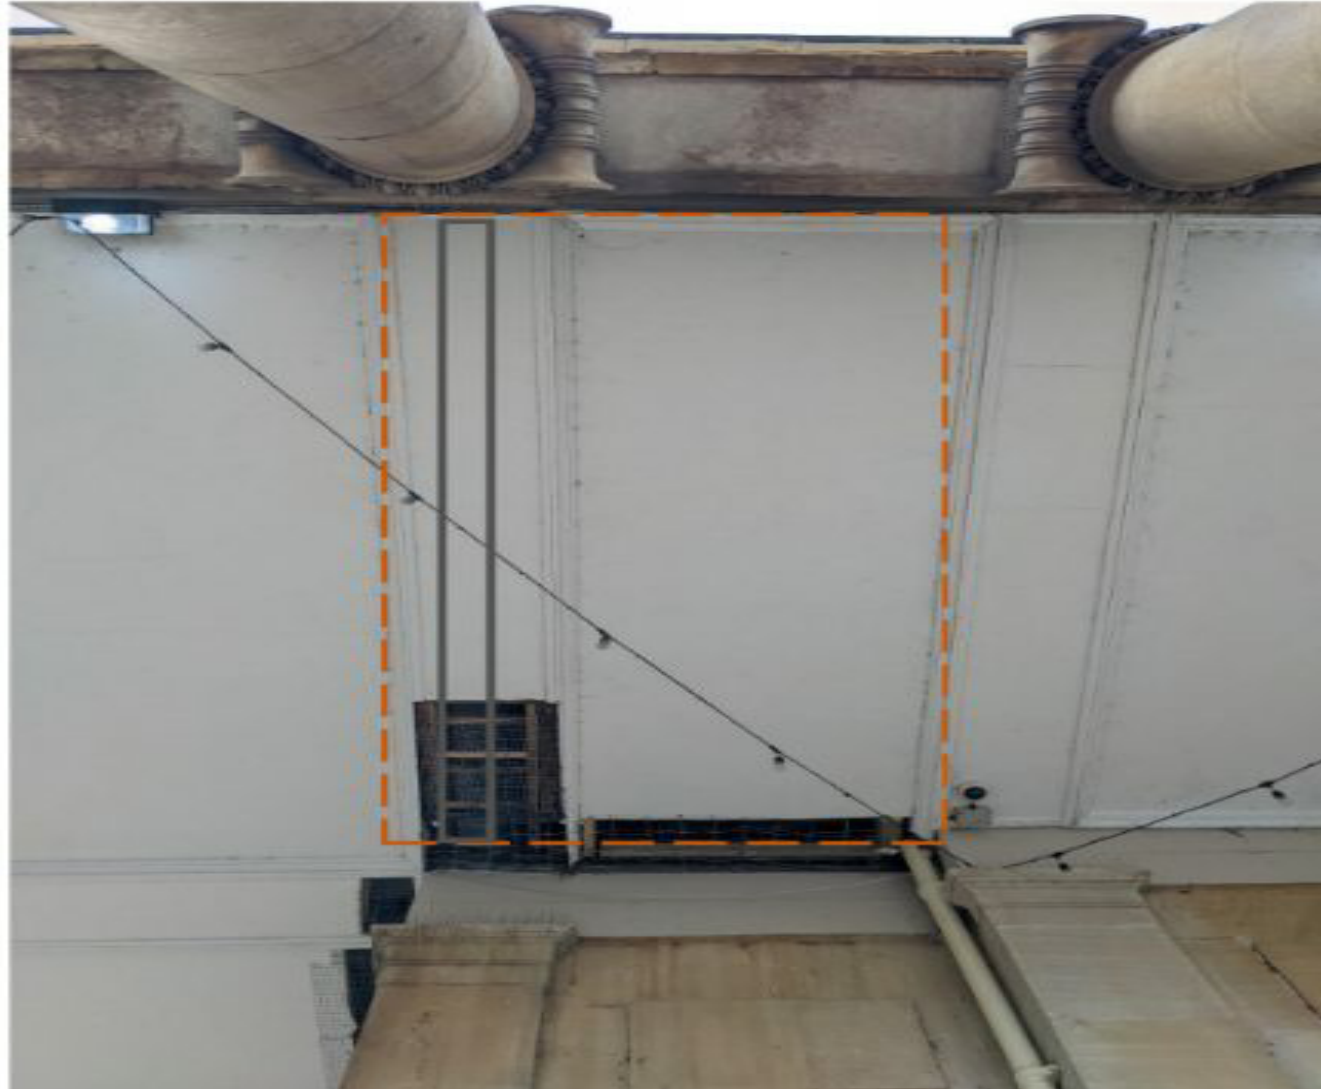
Area to be opened up for inspection by Clarke Nichols Marcel – hatched area in drawing 01.

Double Timber beam location for repairs.

ALL PLATES TO BE 10mm THICK GRADE S275.
ALL WELDS TO BE CONTINUOUS RUNN FLUET WELDS.
PLATE A - 305mm WIDE BY 1115mm LONG.
PLATE B - 140mm DEEP BY 1115mm LONG WELDED TO
PLATE A 800mm LONG.

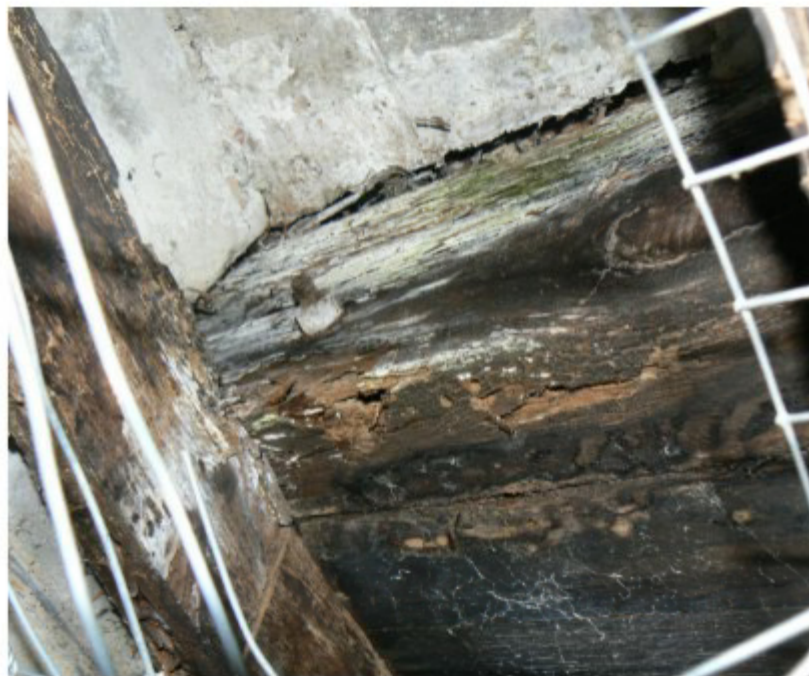
PHOTOGRAPH P1

(DOUBLE TIMBER ARRANGEMENT ASSUMED MAIN ROOF SUPPORT BEAM)
