Chargrove Lane, Cheltenham

Hydrology Report

July 2014

Hydrologist report investigating the effect of reducing the volume of a garden pond by 40%.

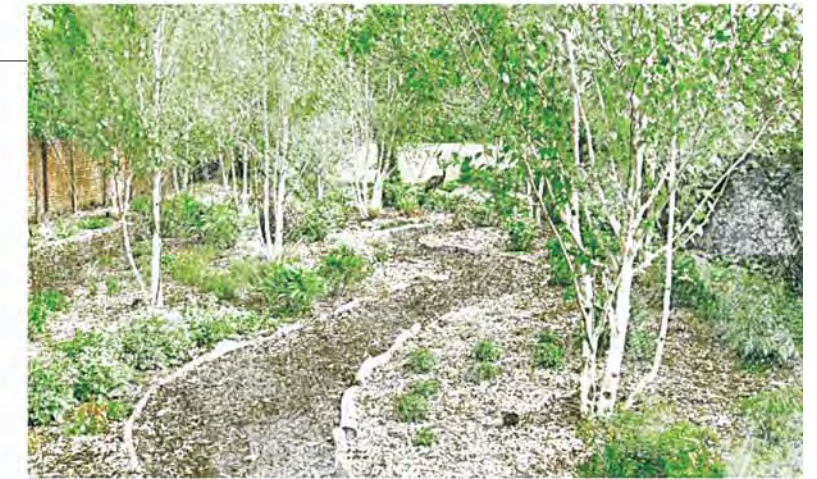
Woodland Walk

Woodland walk, utilising existing trees, with a curved path between composed of bark mulch. Informal arrangement of *Athyrium niponicum*, *Dicentra eximia*, *Dryopteris atrata*, *Lamium maculatum*, *Liriope muscari*, *Pulmonaria saccharata*, *geranium macrorrhizum*, *lathyrus vernus*, *anemone sylvestris* and *arum italicum*.

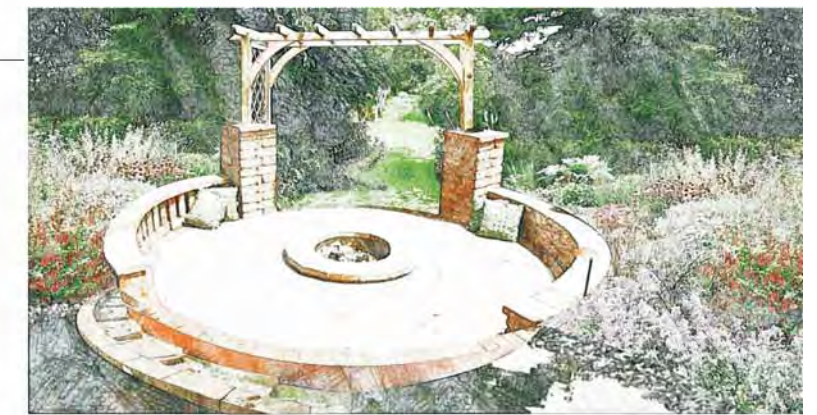
Patio Area / Flower Beds

Secondary pond, at level of patio area to encourage water movement and allow planting of marginal plants, to include an informal arrangement of: *Veronica spicata*, *Phlox subulata*, *iris ensata*, *iris sibirica*, *Lythrum salicaria*, *Mentha aquatica* and *Mazus reptans*.

Steps down to pond with small paved seating area with bench, straddled by terracotta pots planted with *Acer palmatum*.
