Spring Bridge, London Road, Charlton Kings

25/00325/LBC

Repair of north headwall and wing walls
over a length of approximately 20m.

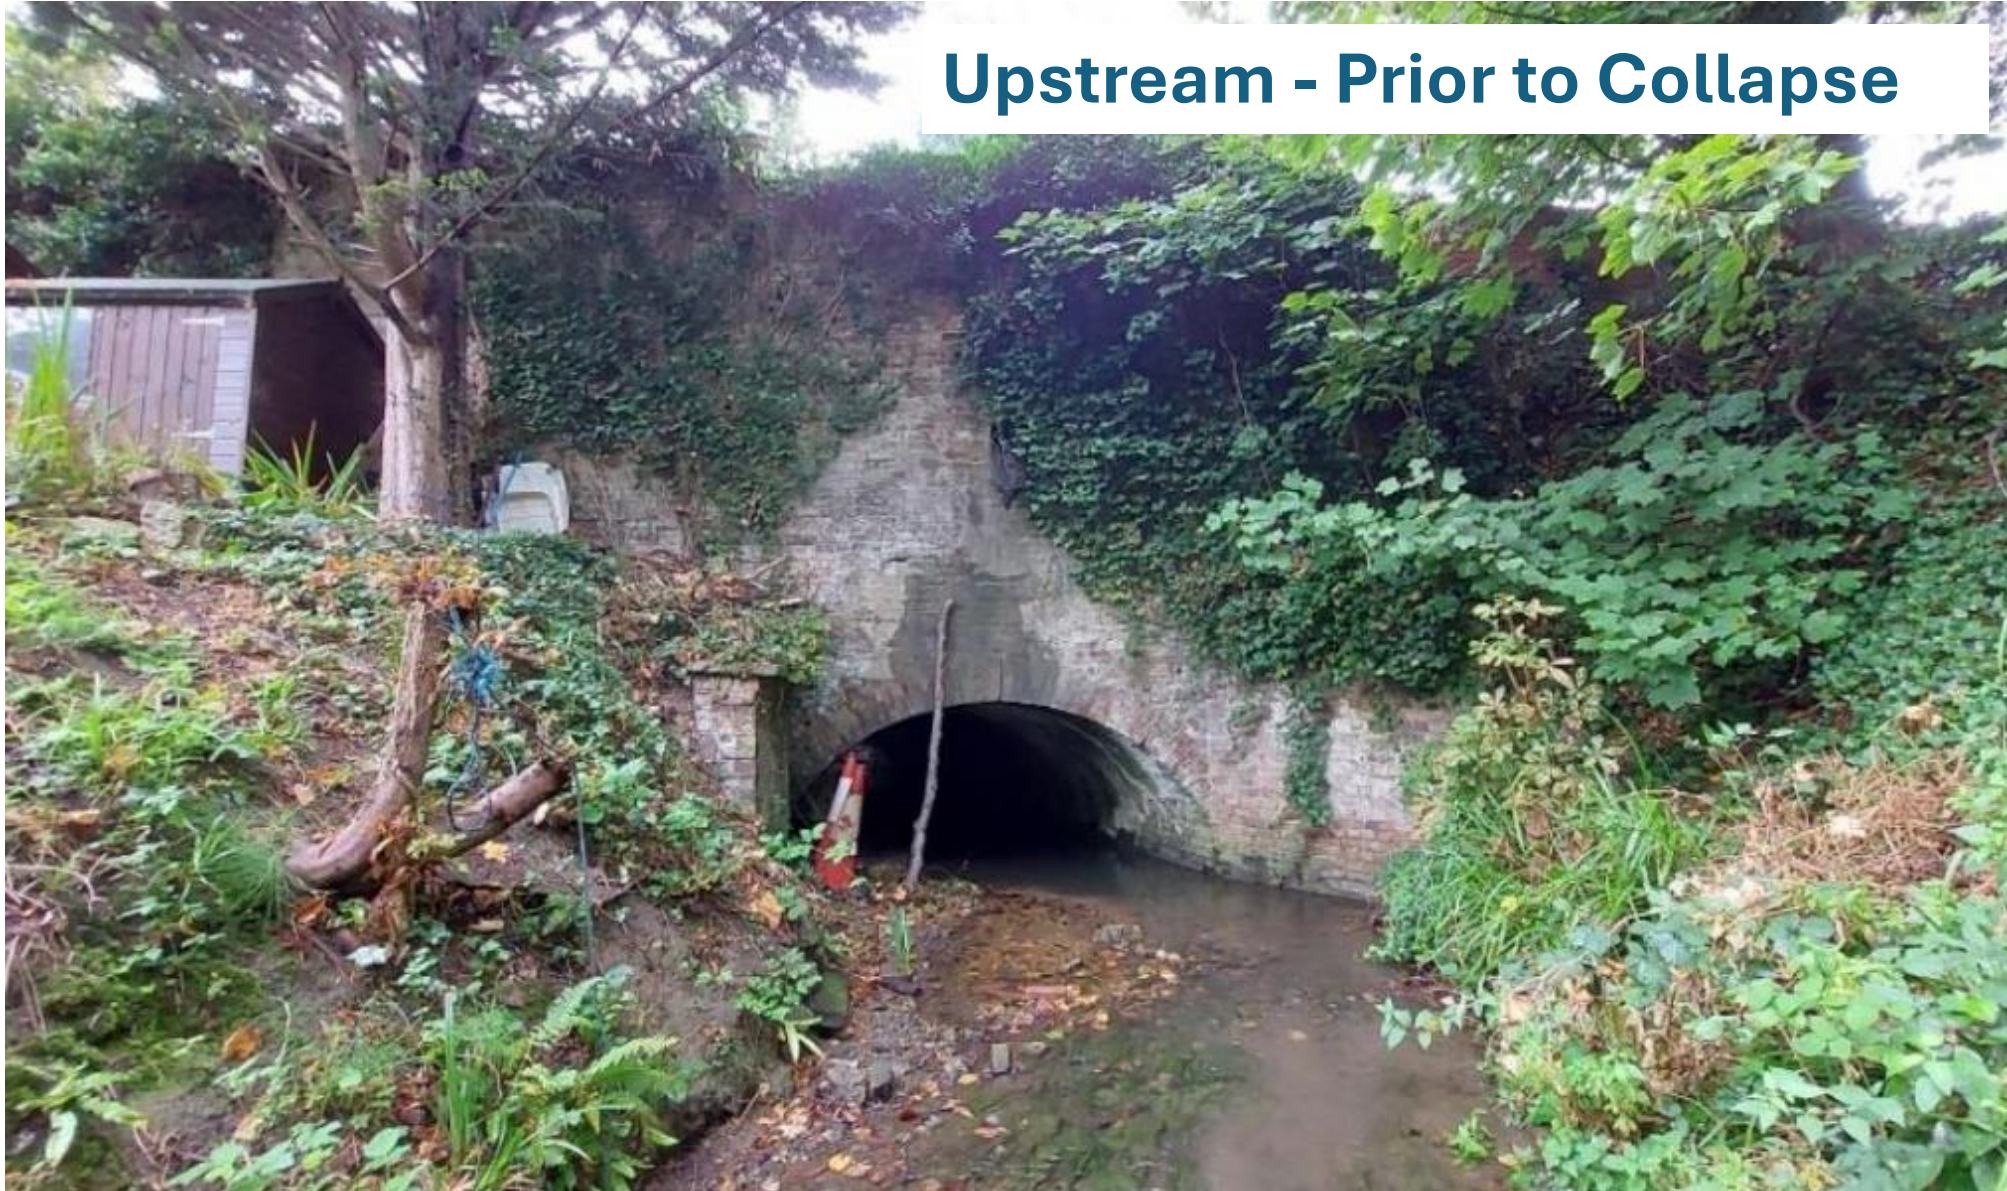
Upstream – Following Collapse

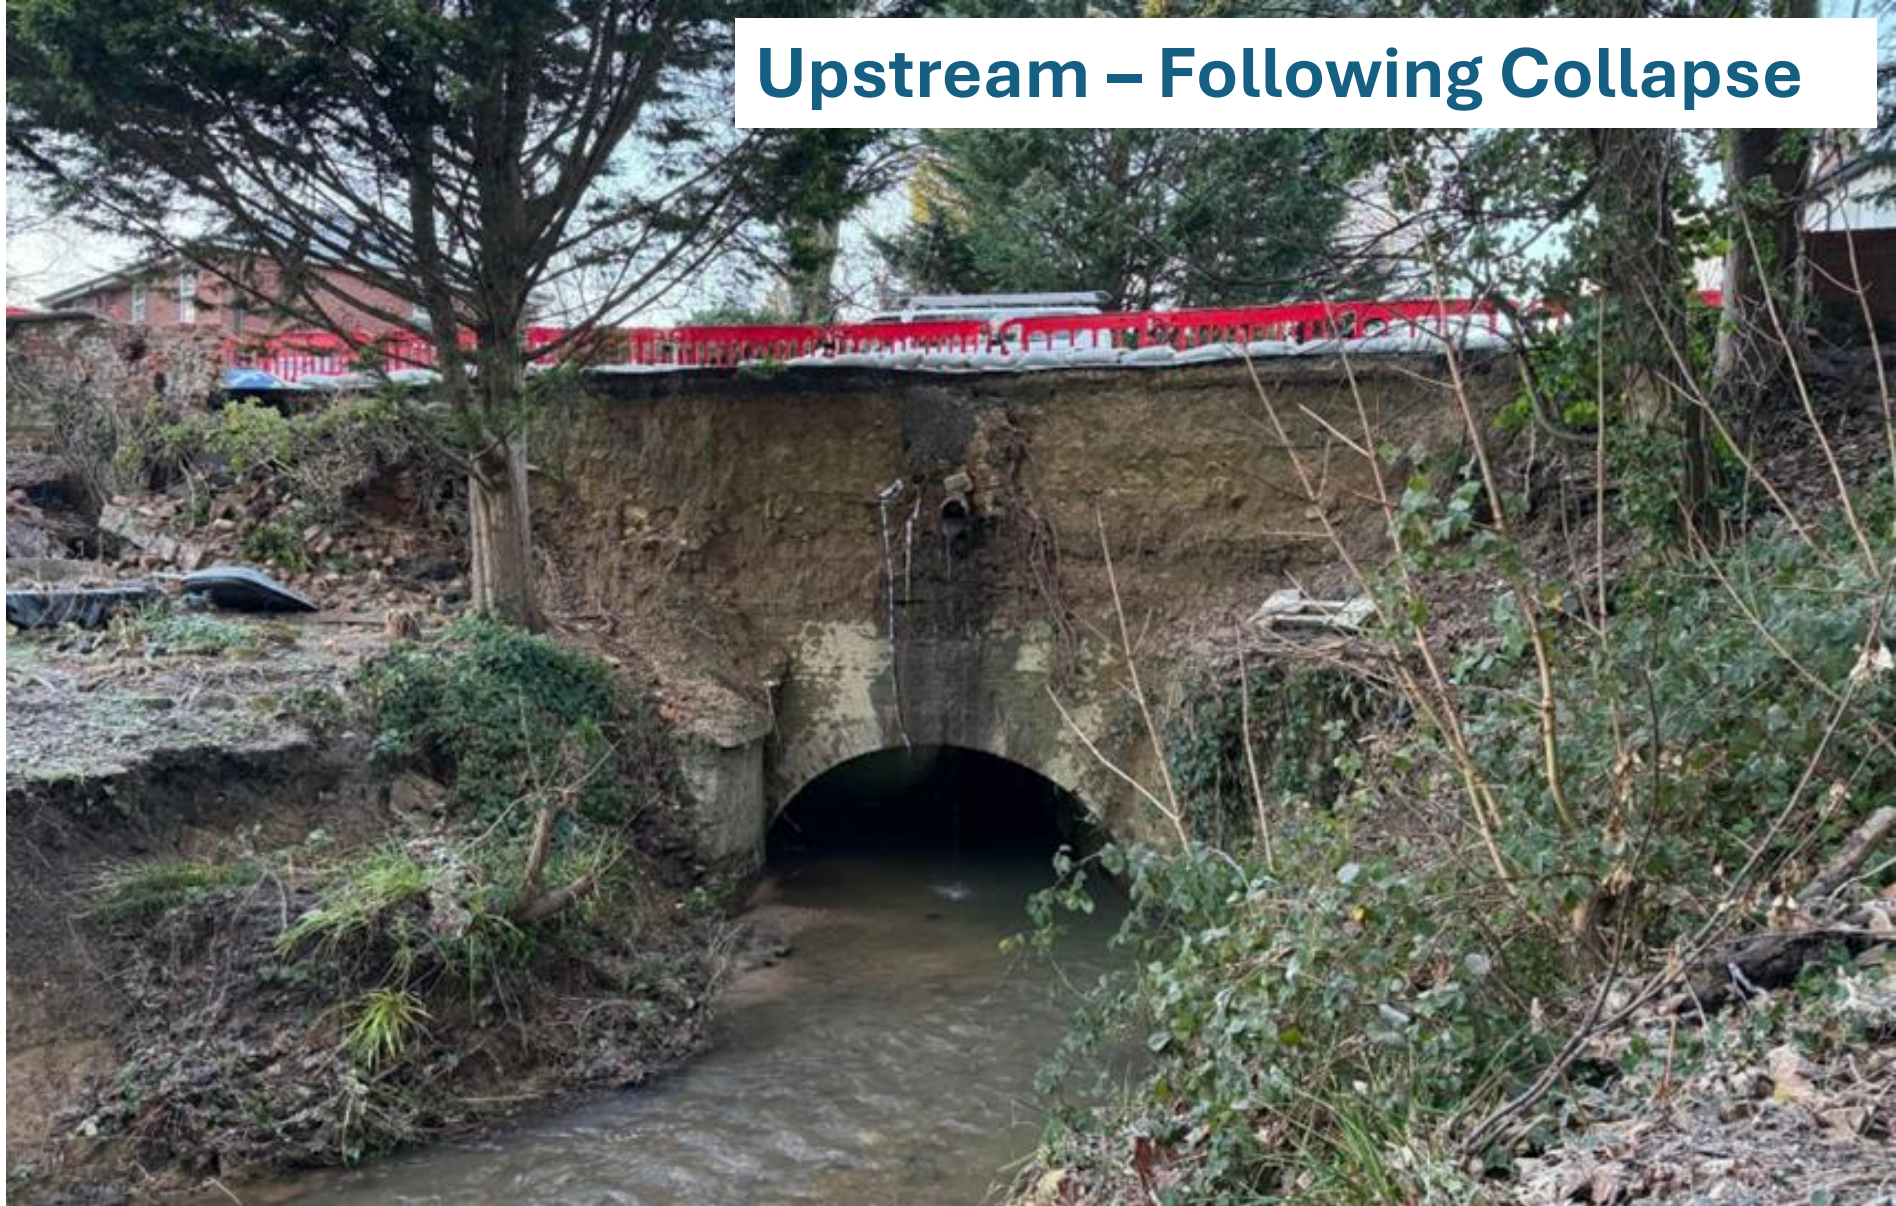
Upstream – Following Collapse

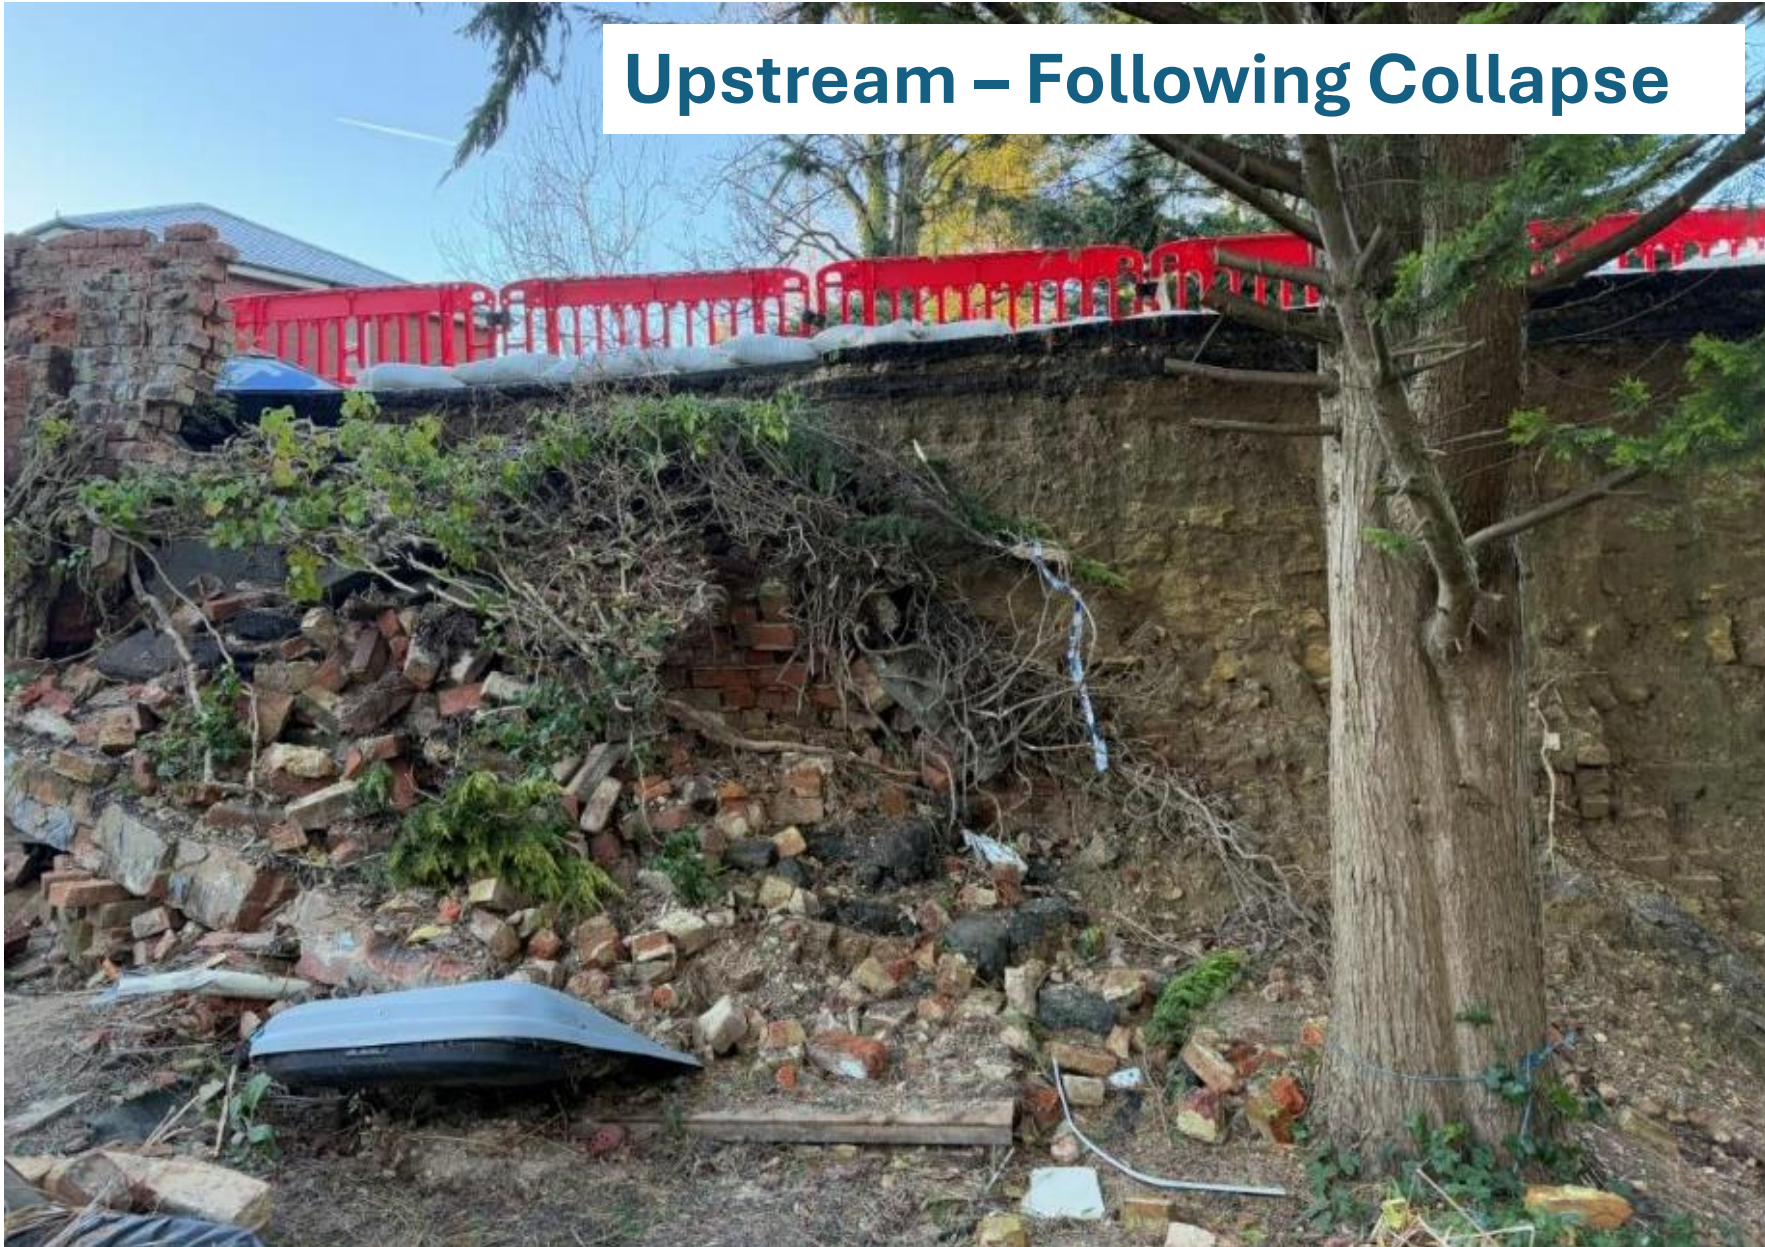
Upstream Parapet Wall –Prior to Collapse

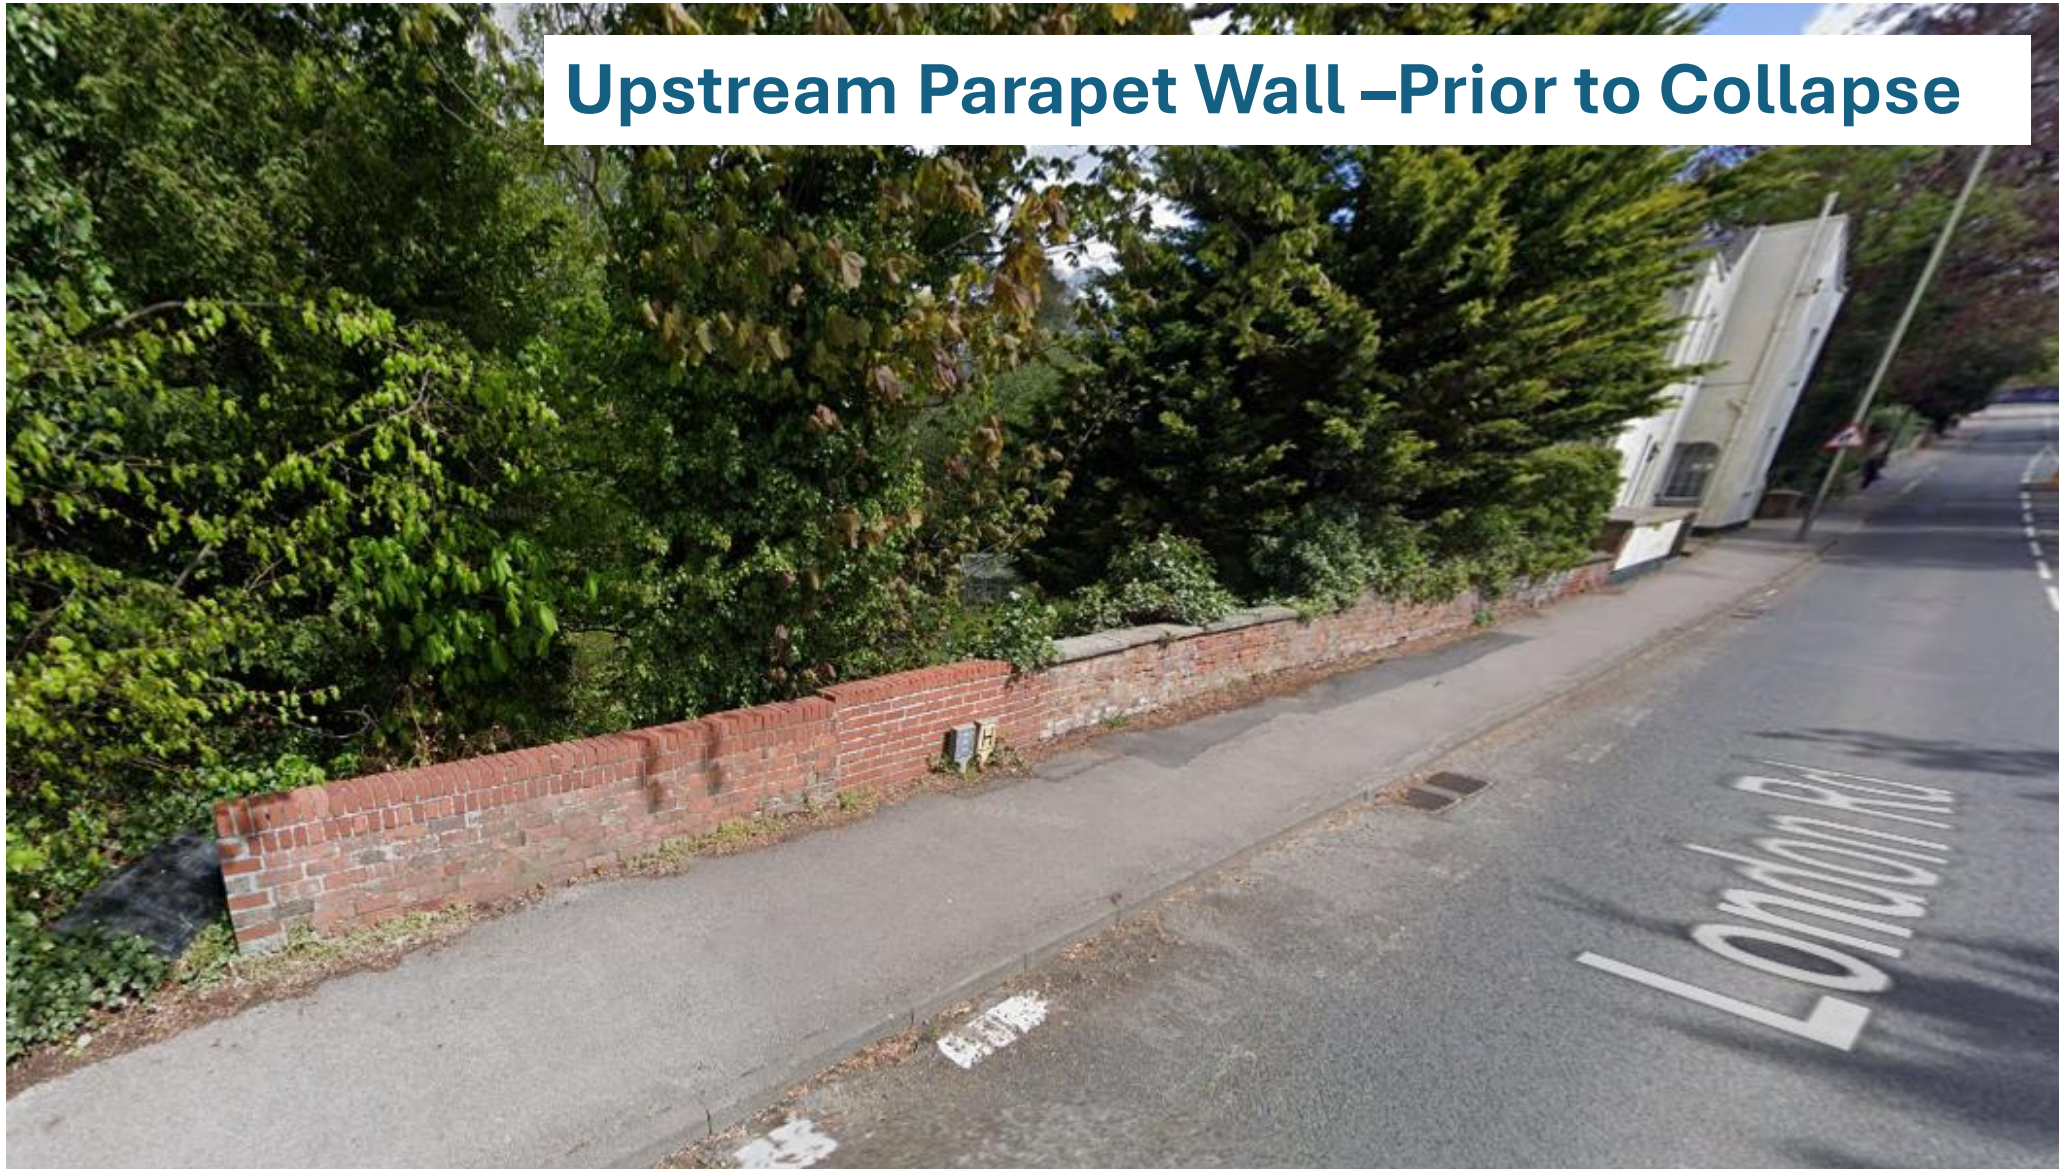
Upstream Parapet Wall – Following Collapse

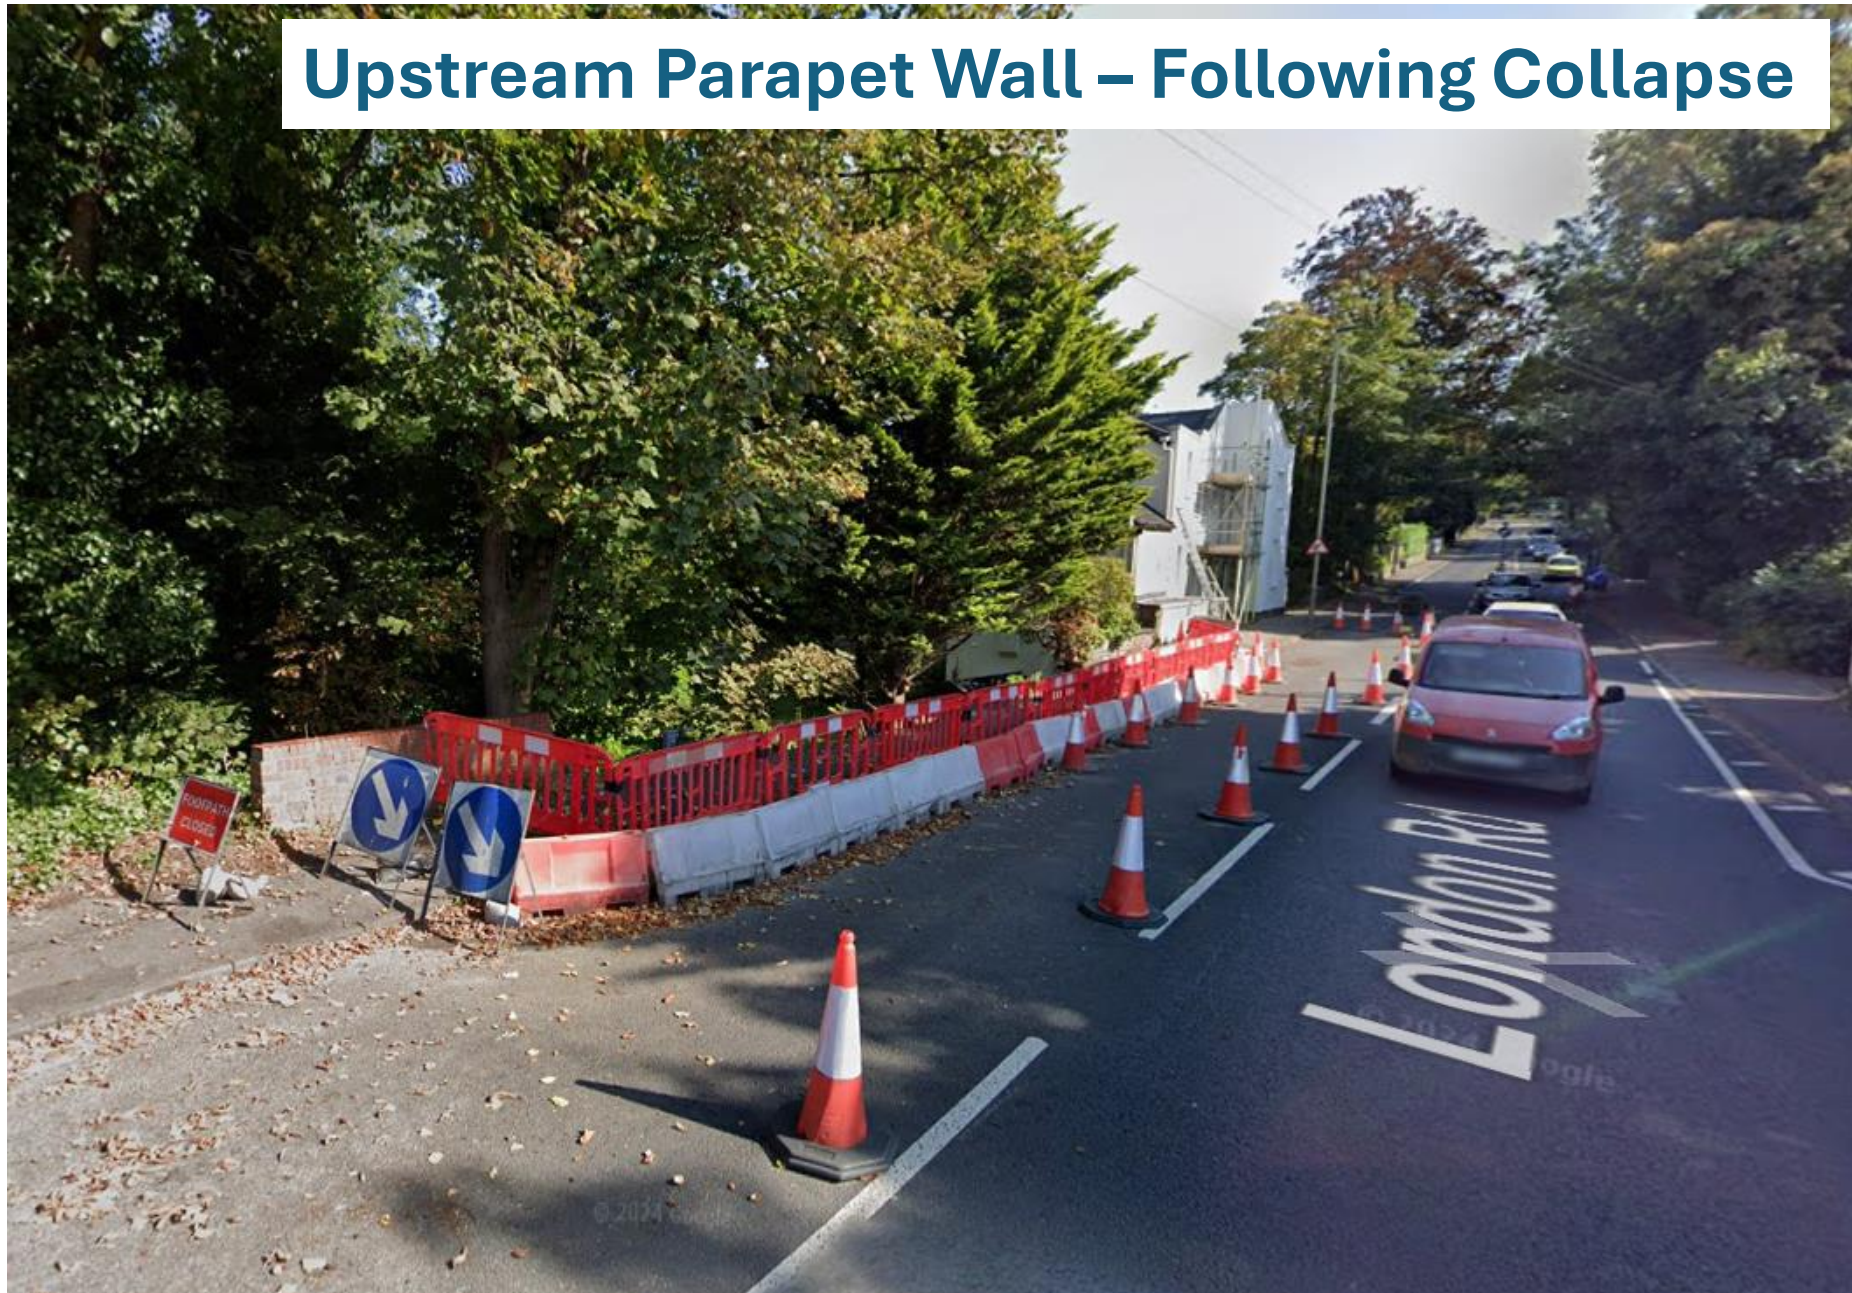
General Arrangement and Excavation Area
