Pedicab Safety Evaluation

UPR SE/052/04

PEDICAB SAFETY EVALUATION

Prepared for: Project Record: Pedicab Safety Evaluation
Client: Licensed Taxi Drivers Association (LTDA)
(Bob Oddy)

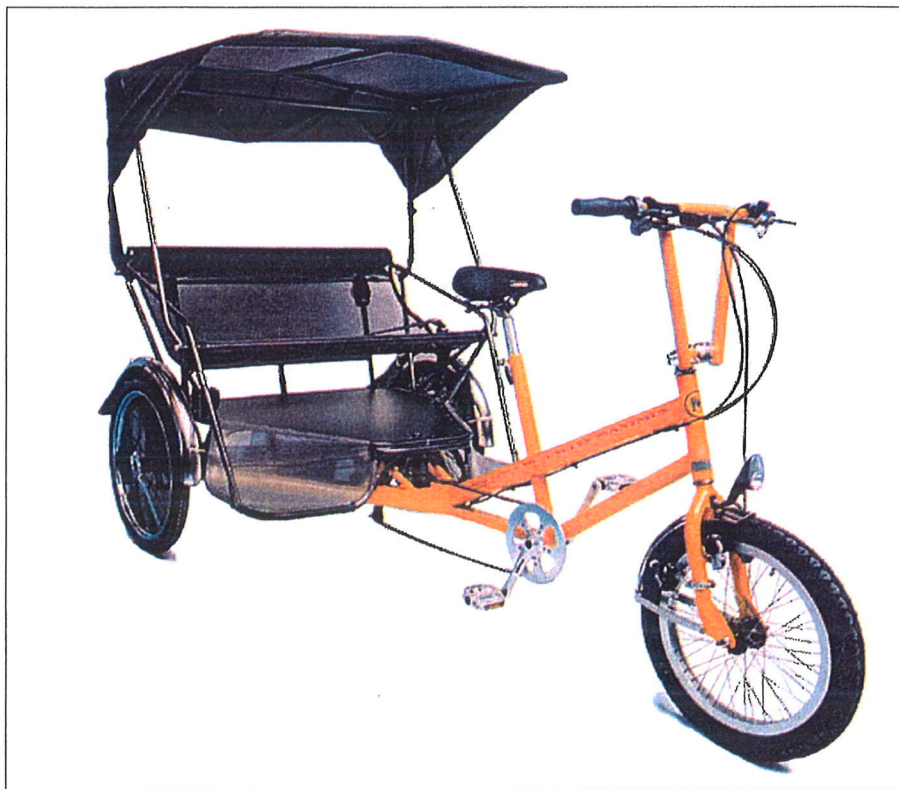
Figure 1: Test Vehicle

The LTDA supplied TRL with a sample Pedicab as illustrated in Figure 1.

The vehicle weighed 75kg, had a wheelbase of 1.85m and a track of 1.2m. The vehicle was equipped with an eight speed derailleur driving a three speed hub. The vehicle was equipped with a chain driven differential driving a hollow rear axle. The front wheel had a hydraulic rim brake and the rear wheels had hydraulic disc brakes using 185mm diameter discs.

The rear seating compartment was fitted with one lap belt designed to restrain the passengers. It should be noted that although it is most common for a Pedicab to carry two passengers, they can carry three, all of which would be restrained by the single lap belt.

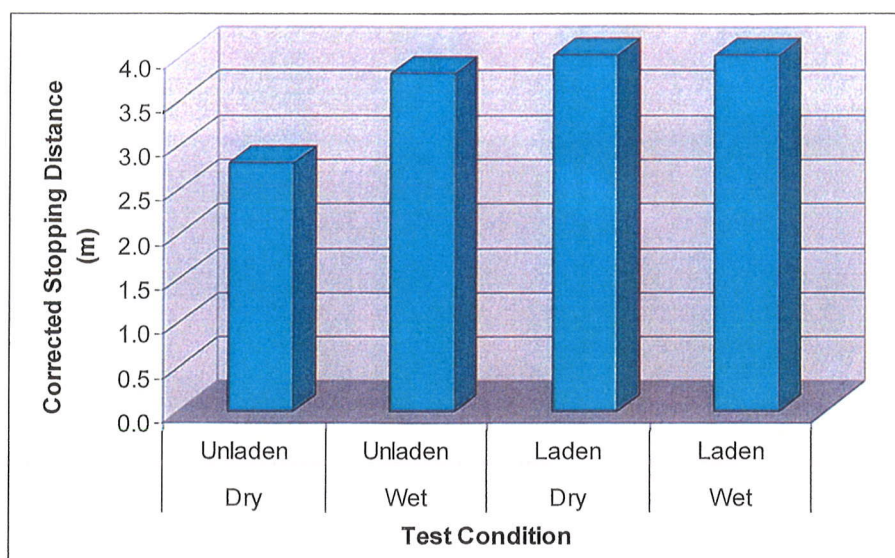
Figure 3: Corrected stopping distances

Figure 3 shows corrected stopping distances for the straight line braking tests. The results show that the Pedicab had the shortest stopping distance when unladen on a dry road surface. When the brakes were fully applied in these tests both the rear wheels locked causing the vehicle to skid to a complete stop. The front brakes did not have enough power to lock the front wheel at any point. When the wheels lock, the braking performance of a vehicle becomes limited by the coefficient of friction of the road. When the road surface was wetted, the friction was reduced and so the stopping distance of the Pedicab increased by approximately 35%.

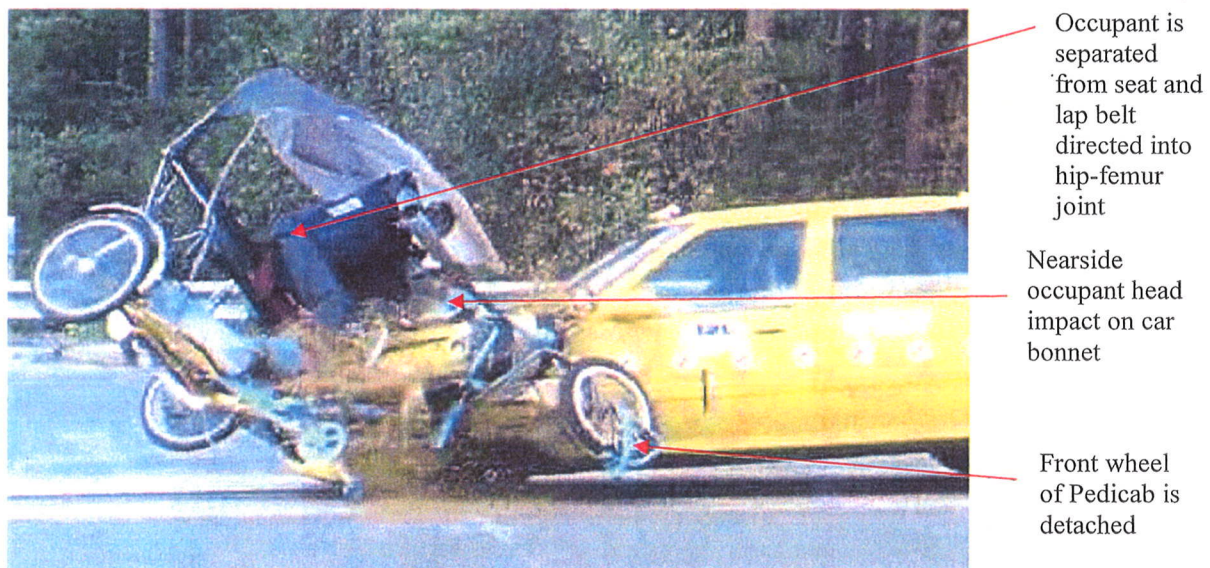
Figure 13. Observations during impact

- The first contact between the car and the Pedicab occupants occurs at 25ms when the leading edge of the car bonnet contacts the left lower leg of the nearside occupant. Although this contact does not cause any movement to the torso of the dummies, it may induce very large forces into the lower limbs of the nearside occupant.

- From 100ms to 200ms the Pedicab is lifted completely off the ground and rotates about the leading edge of the car bonnet and the dummies are accelerated to a velocity close to that of the car.

- The head of the nearside occupant makes contact with the bonnet of the car approximately 160ms after the initial contact between the vehicles
- The offside occupant is separated from the seat of the Pedicab, but this is restricted by the lap belt. However, the lap belt is directed into the joint between the hip and femur.

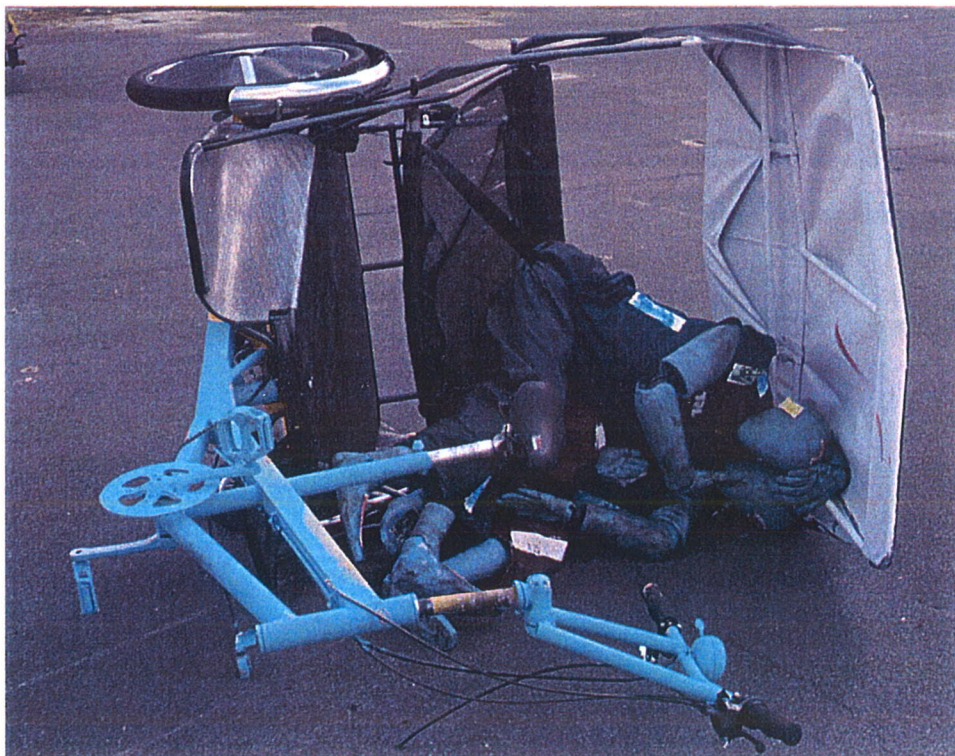
Figure 15. Pedicab and occupants in final resting position

- The canopy prevents the head of the offside occupant impacting the car. There was contact between the heads of both of the dummies and the canopy
- There was also considerable abrasion to the rear of the head and shoulders of the nearside occupant where the Pedicab slid across the ground after it separated from the car.
