RESTORATION OF CHELTENHAM WAR MEMORIAL

Condition survey and conservation options appraisal

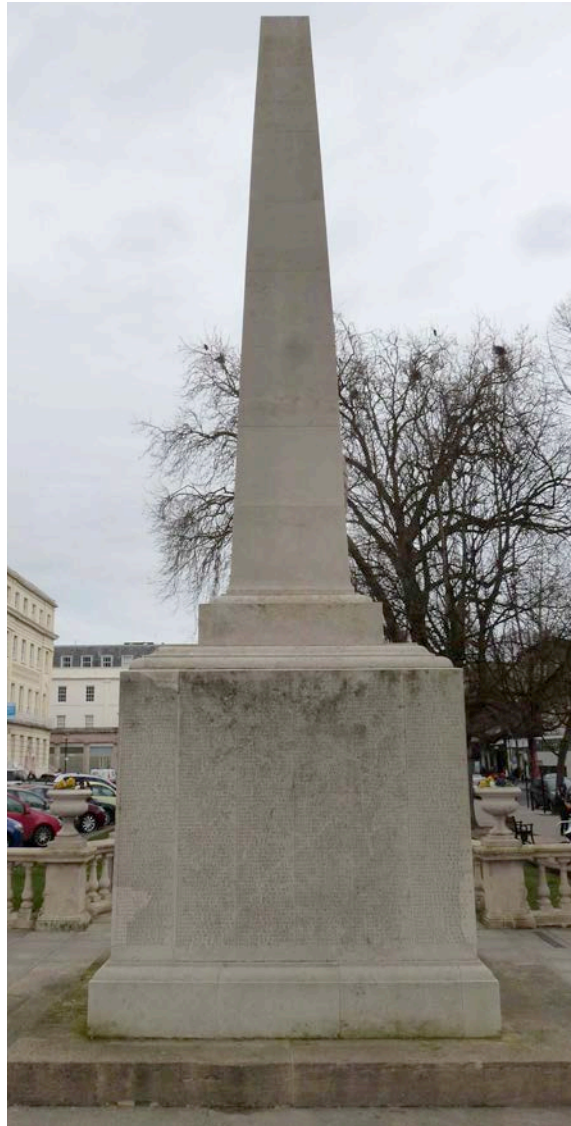
The condition of the plinth is generally good although there is some cracking of vertical pointing as well as the spalls in the stone adjacent to the joint (see 'Structure'). The inscription panel also has a repaired spall at the base (Fig 19). The stone of the inscription panel is generally sound but there is some algal staining and more general erosion at high level. The mortar joints are intact although there is some cracking and disruption in the vertical joint with the west elevation inscription panel. There are two indents in the return of the west elevation inscription panel and one in the corresponding stone on the east side.

The horizontal joint at the top of the inscription is cracked (Fig 20) and there is some mortar repair on the top (sky-facing) ledge. The moulding has a flat top surface where water tends to collect; as a result, it is generally eroded with localised cavities of up to 5mm depth; some of these are due to clay-rich pockets within the stone. The obelisk plinth also has erosion but not to such a great extent as water is able to run off easier.

The obelisk stones are generally sound with overall erosion of about 1 – 2mm; the evenness of the surface suggests that the surface may have been tooled off. This is supported by tool marks still visible on the third stone from the bottom (Fig 21) as well as a slight irregularity in the arris which does not have the precision that might be expected from the original masonry. The lowest stone has some slight surface deterioration and there is a very fine crack/shake in the stone just to the east of centre.

Fig 18: general view of south elevation

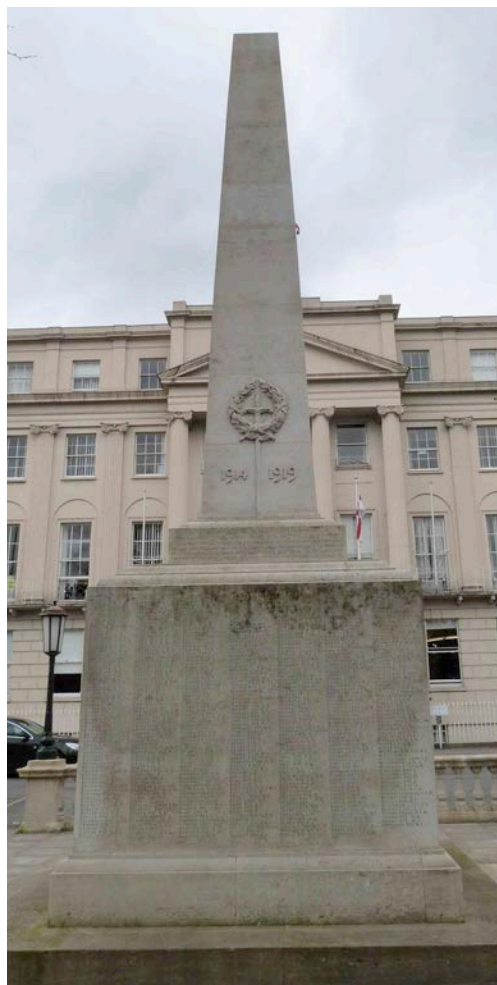
The plinth (which consist of three stones on this side) is generally sound with one of the stones being particularly shelly. The monolithic inscription panel has erosion and staining at high level and, at low level, there is some minor lamination of the surface. This appears to be due to a yellower clay-rich bed within the stone.

Fig 22: overall view of east elevation

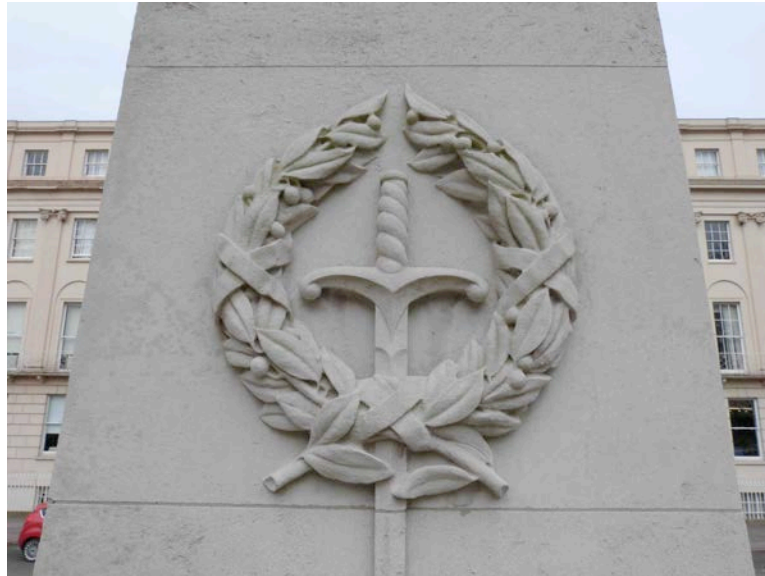
The obelisk stones are sound albeit eroded. There is again a discernible inaccuracy to the arris which suggest that the stones have been re-tooled but there is no evidence of this around the two lower stones, both of which have relief carvings. The wreath (Fig 26) and the sword (Fig 27) are sound except for the tip of the sword where there is slight lamination of the stone (Fig 28). The stone around the lower 'lip' is more generally eroded. The mortar in the joint between the lowest two stones of the obelisk is cracked.

Fig 26: detail of wreath

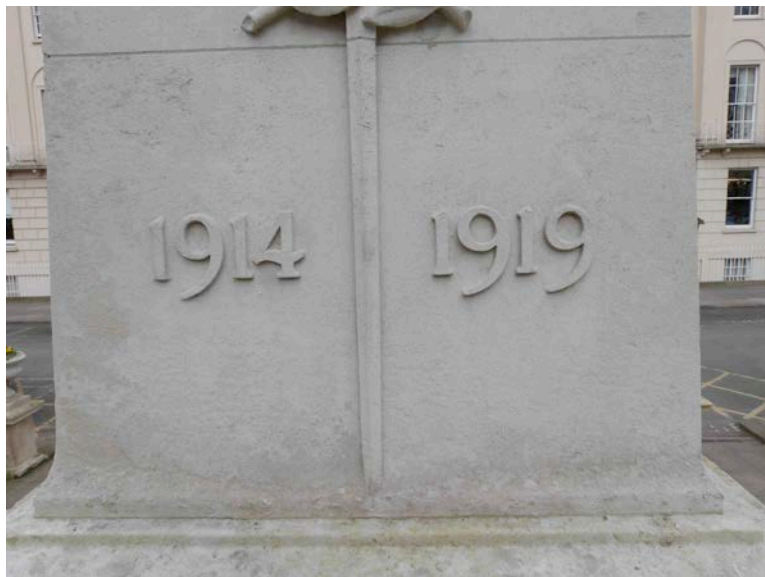
Fig 27: detail of sword and date inscription

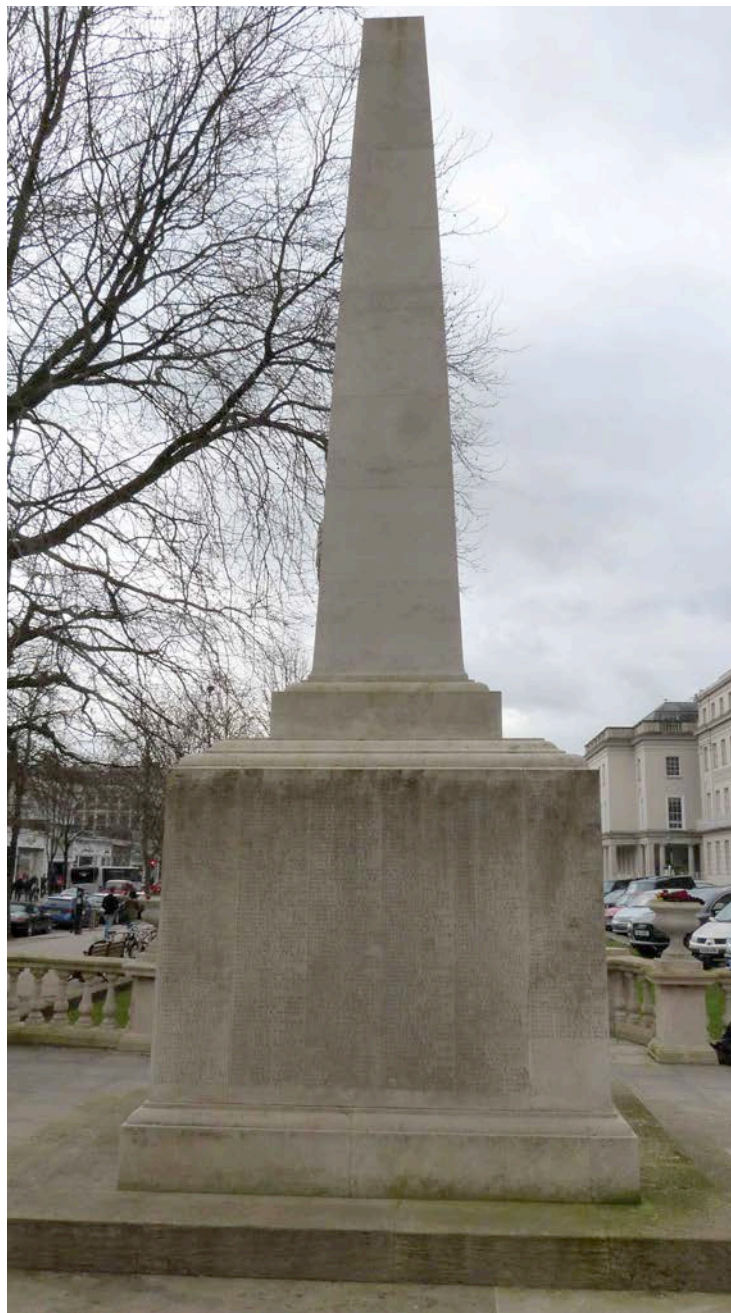
The plinth is generally sound but there are cracks in the pointing of both horizontal and vertical joints. There is a small spalled section of stone due to the corrosion of a cramp between stones of the plinth.

Fig 29: overall view of east elevation

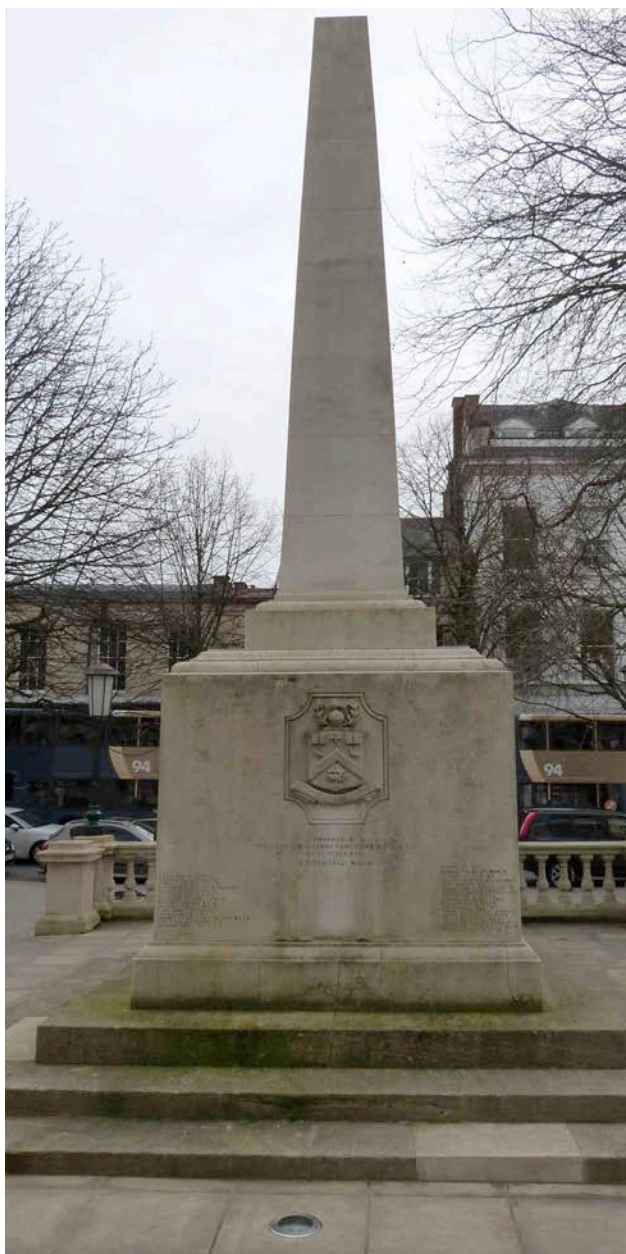
The plinth stones are sound except for the vertical crack through the middle of the central stone immediately above the joint in the step (see 'Structure'). The pointing in both the vertical joints and the horizontal joint at the top of the plinth is cracked.

Fig 32: overall view of west elevation

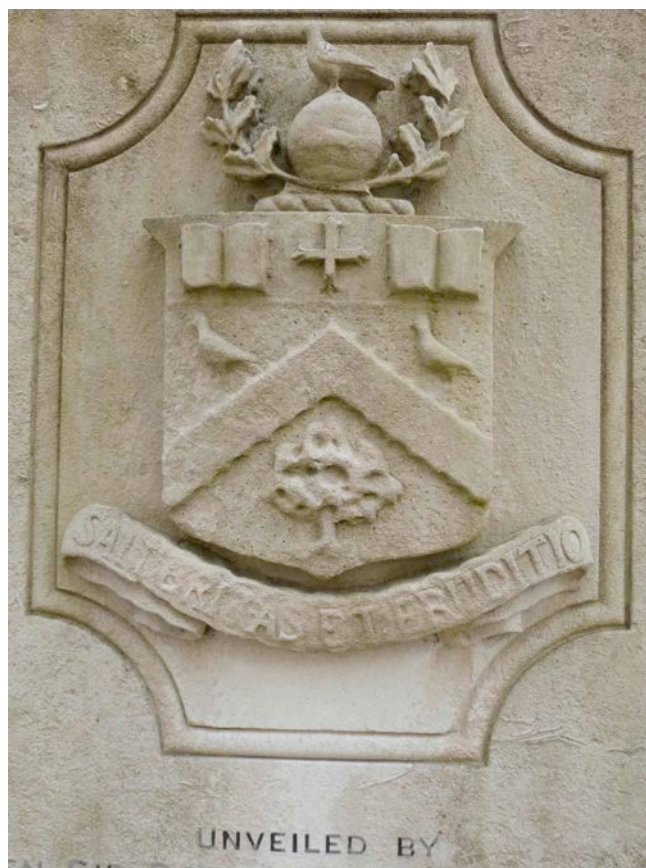
The monolithic inscription panel has some staining at high level due to water run-off but the area beneath the protruding has differential staining. In general the protected areas are clean and without erosion but the exposed areas of the carving (lower half of shield and ribbon) are very worn and continue to decay (Fig 33). The lower section of the panel displays similar surface deterioration of clay-rich beds as was found on the corresponding stone on the east elevation.

Fig 33: detail of carved shield

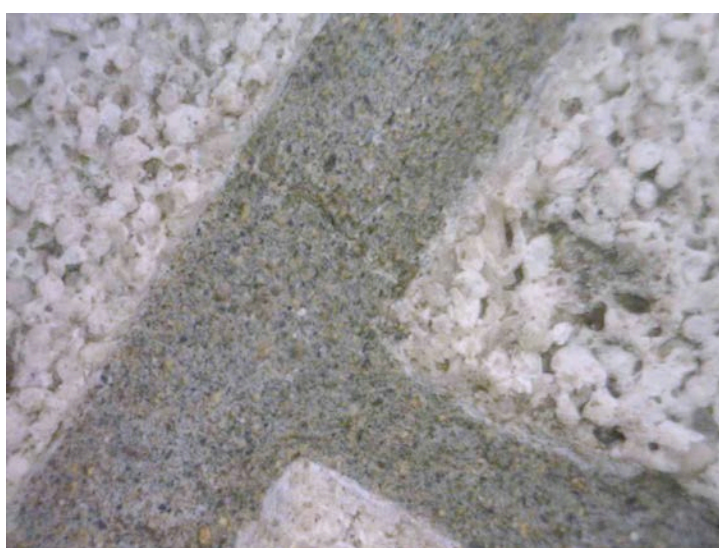
Fig 36: detail of mortar fill (x50 magnification) also showing faint white margin which is probably glue applied to lettering to aid adhesion

It seems likely that lead lettering was the original intention but it is known that there was little money available during the design and construction so, instead of lead, the letters were filled with fine cement based mortar containing sand and some wood ash (Fig 36). This seems to have been applied over a thin coat of adhesive and then given a polished finish (Fig 37) to resemble lead. It may be that the mortar had a small amount of oil included in order to facilitate this polish.

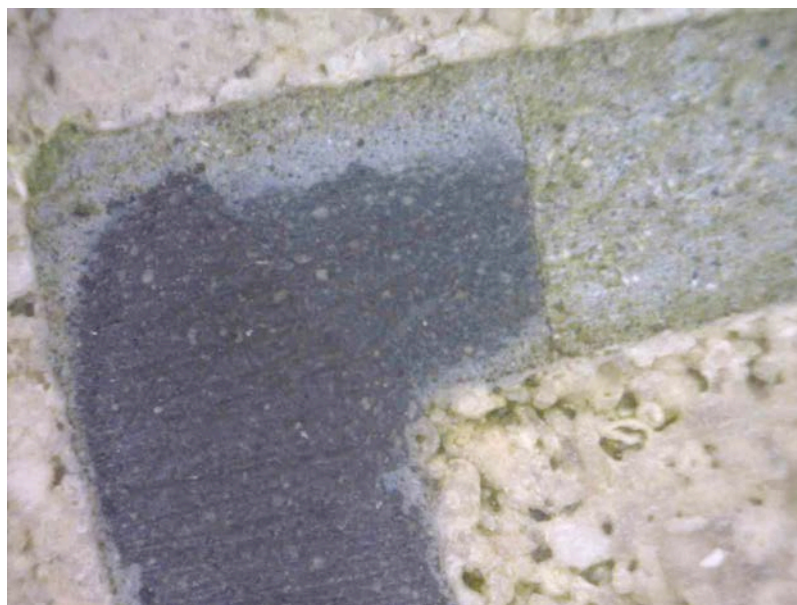
Fig 37: small section of original finish showing dark grey polished appearance

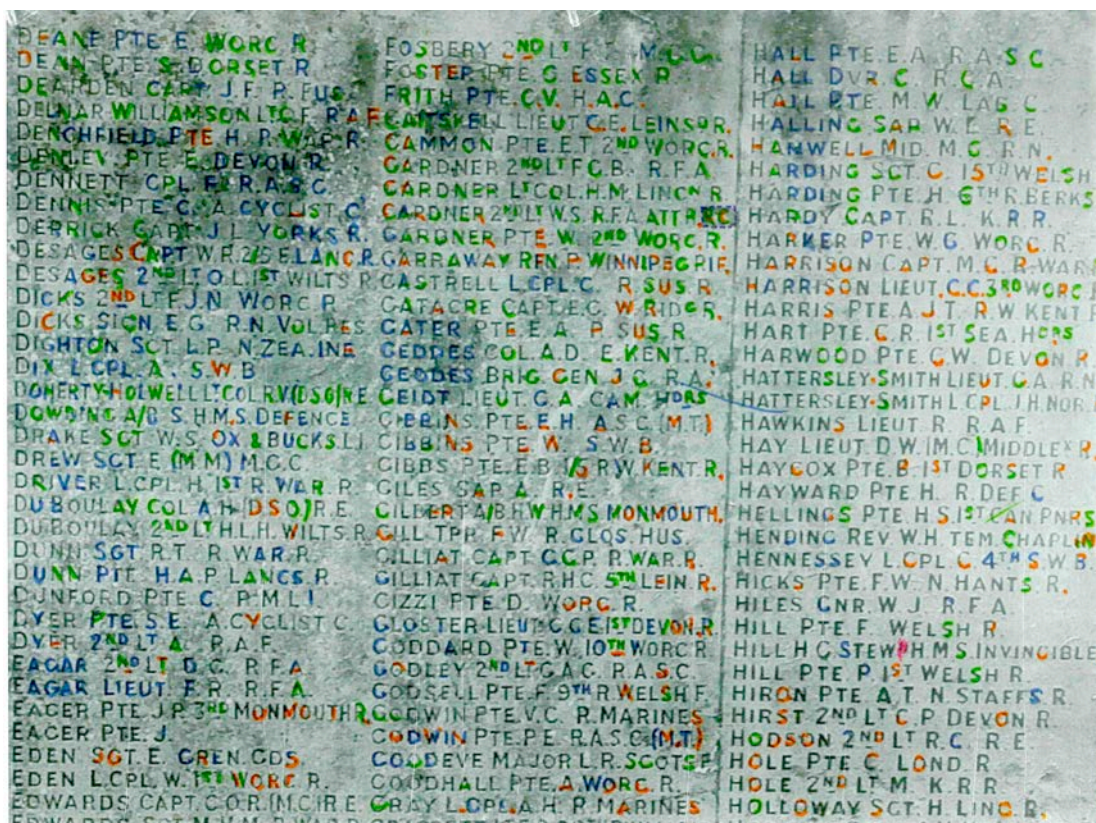
Fig 43: upper east quadrant of south inscription panel

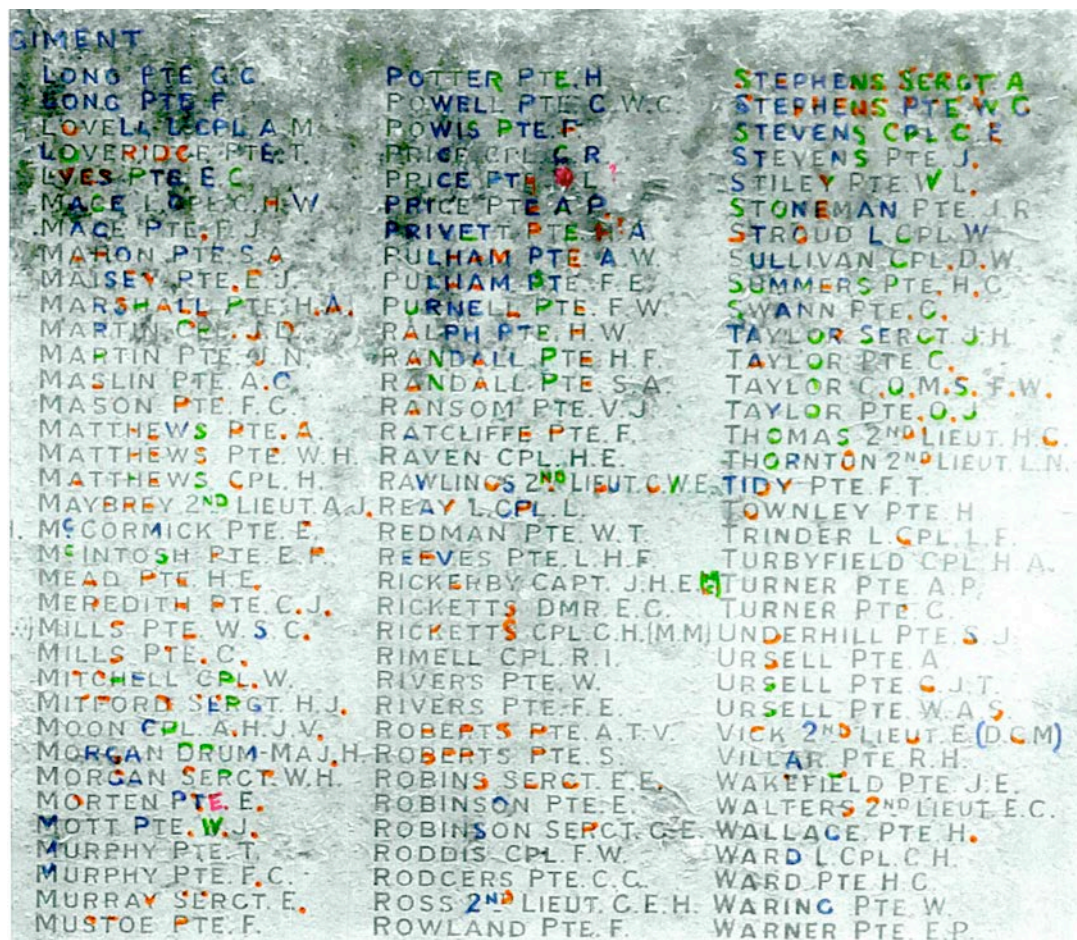
Fig 47: upper north quadrant of east inscription panel

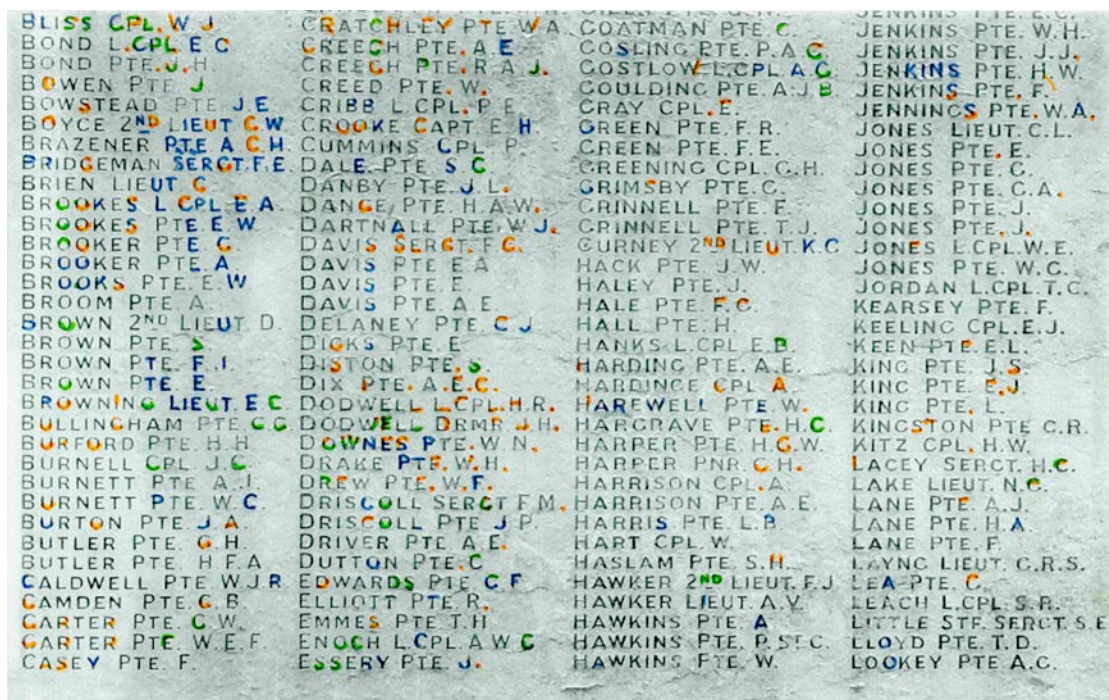
Fig 48: lower south quadrant of east inscription panel

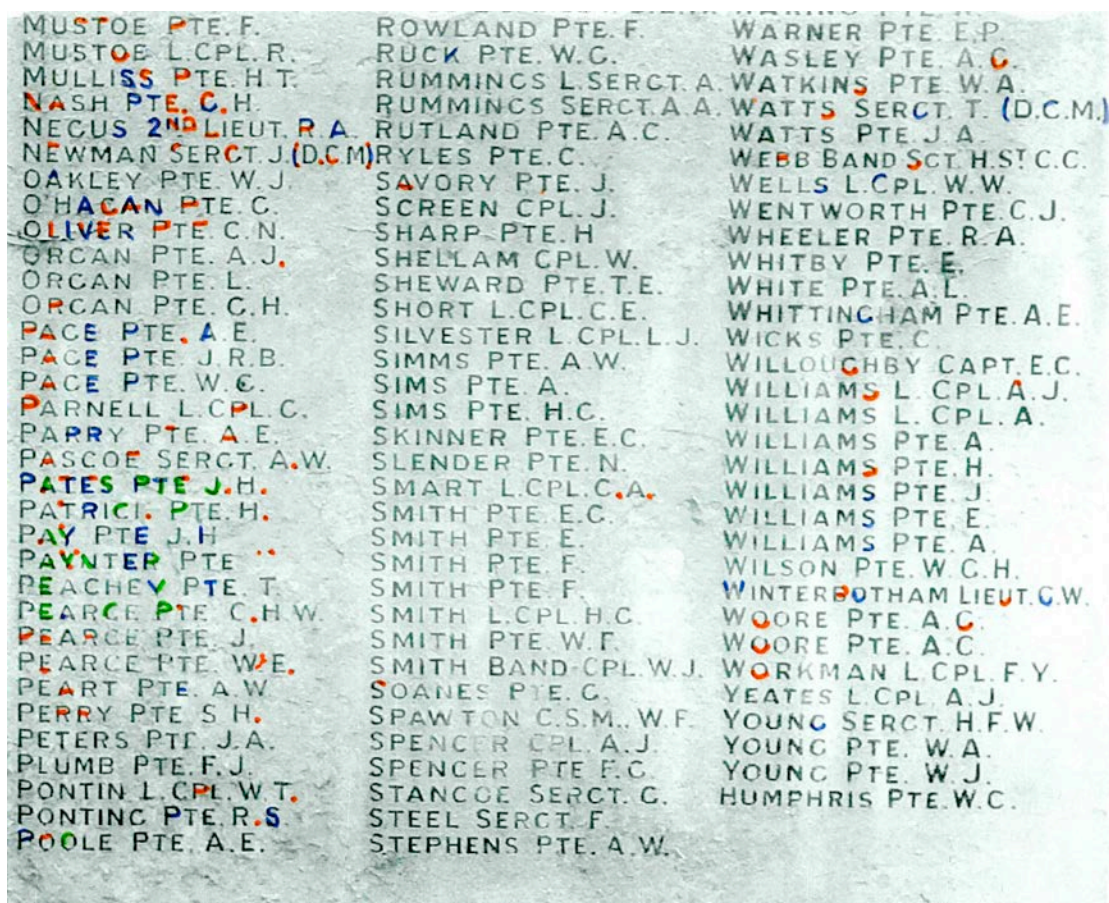
Fig 49: lower north quadrant of east inscription panel

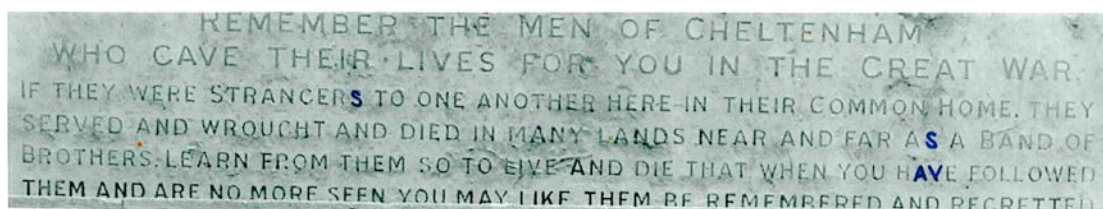
Fig 50: inscription on base of obelisk on east elevation

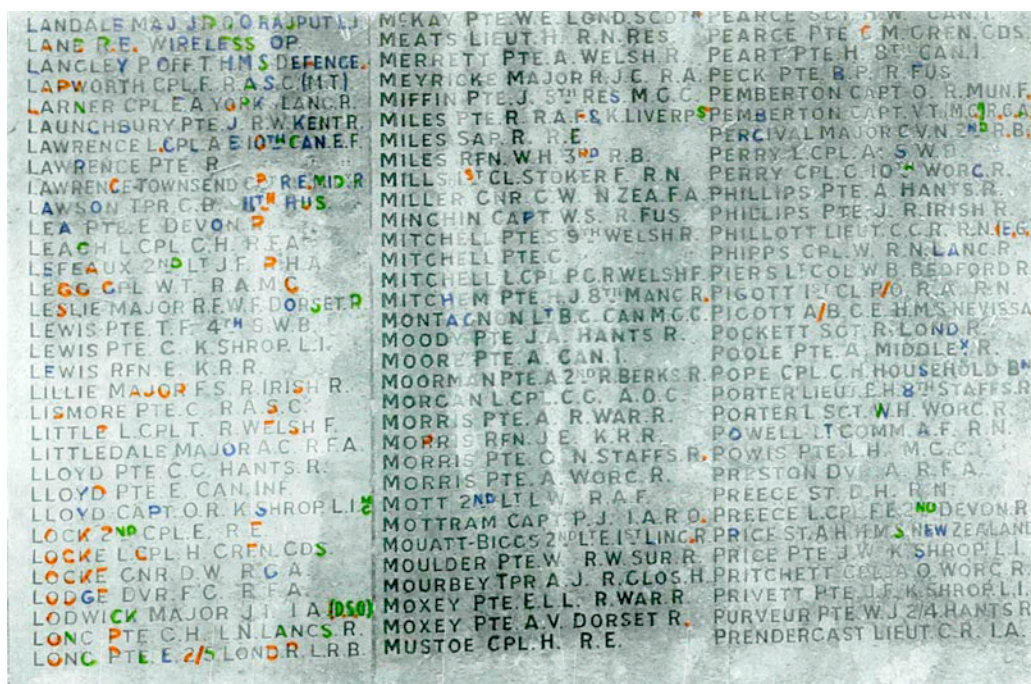
This is more protected from the weather and as a consequence is less eroded but is subject to increased microbiological growth. The current condition shows how the lettering on the upper part of the inscription panel can become obscured by algae. The resulting cleaning of the stonework has resulted in considerable erosion of the infill and loss of detail in this area. The lower half is generally in much better condition with almost all of the lettering still retaining full detail.

Fig 53: lower east quadrant of north inscription

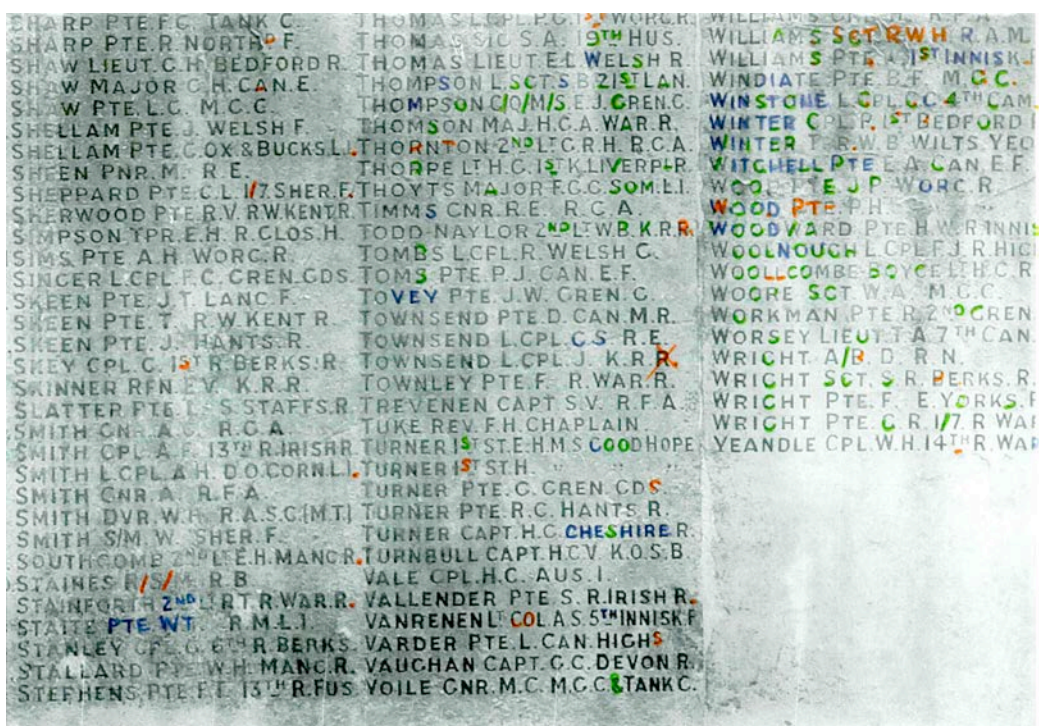
Fig 54: lower west quadrant of north inscription

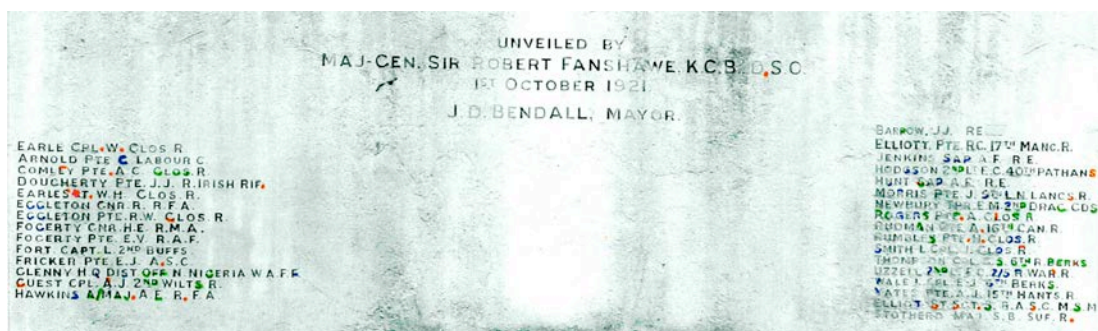
This elevation has much less lettering and some of the infill retains an original dark grey polished surface. The names on the lower south side have been affected by the surface spalling of the stone but the letters remain legible; the lower north side is in better condition. The larger central inscription is in good condition.

Fig 55: inscription on west elevation

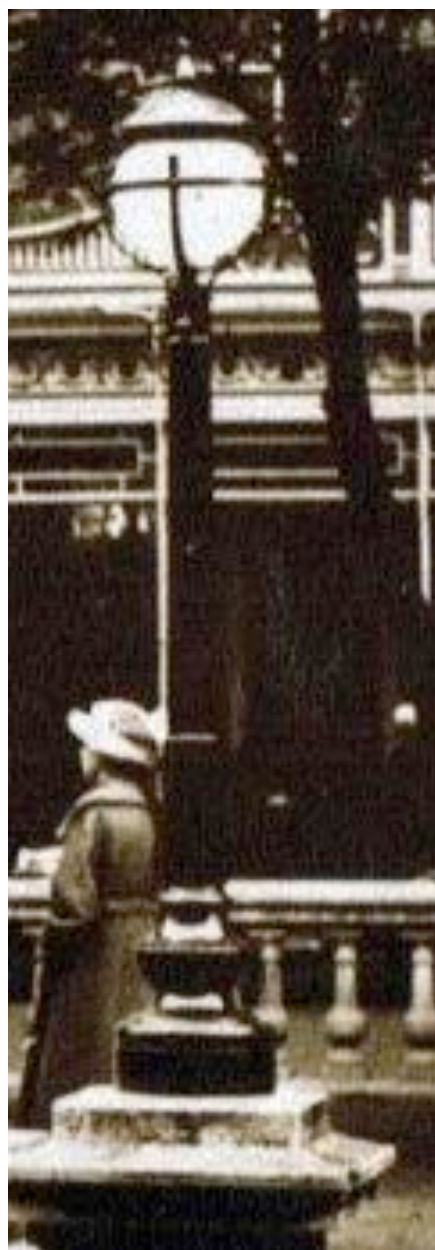
Four lanterns stand at each corner of the memorial and there are a further six along the Promenade. Originally these had a circular stem and, at the top, a glass orb set within a bronze frame (Fig 56). Although examination confirms that the existing stems are original, the tops of the lanterns have been replaced (Fig 57) with the new top secured to the original stem with a collar and hexagonal nut. This is thought to have taken place sometime in the 1950s as a glimpse of the lanterns in a video of the fire at the Municipal Offices on Boxing Day 1960 (https://www.youtube.com/watch?v=oA7_C7mih3I) shows the current lamps to be in place.

Fig 56: detail of original lantern

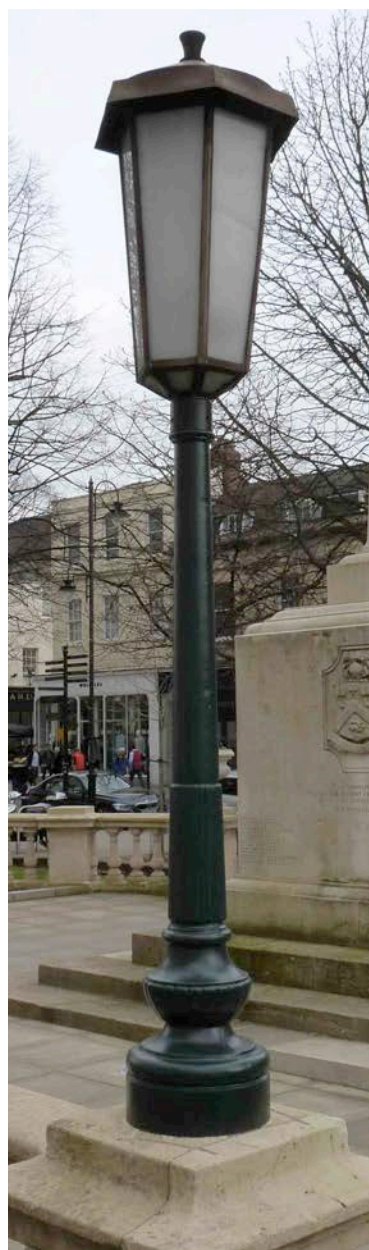
Fig 57: detail of current lantern

As part of the process of restoring the original lanterns, certain patterns are being examined by Barr & Grosvenor Ltd. Further information is awaited.

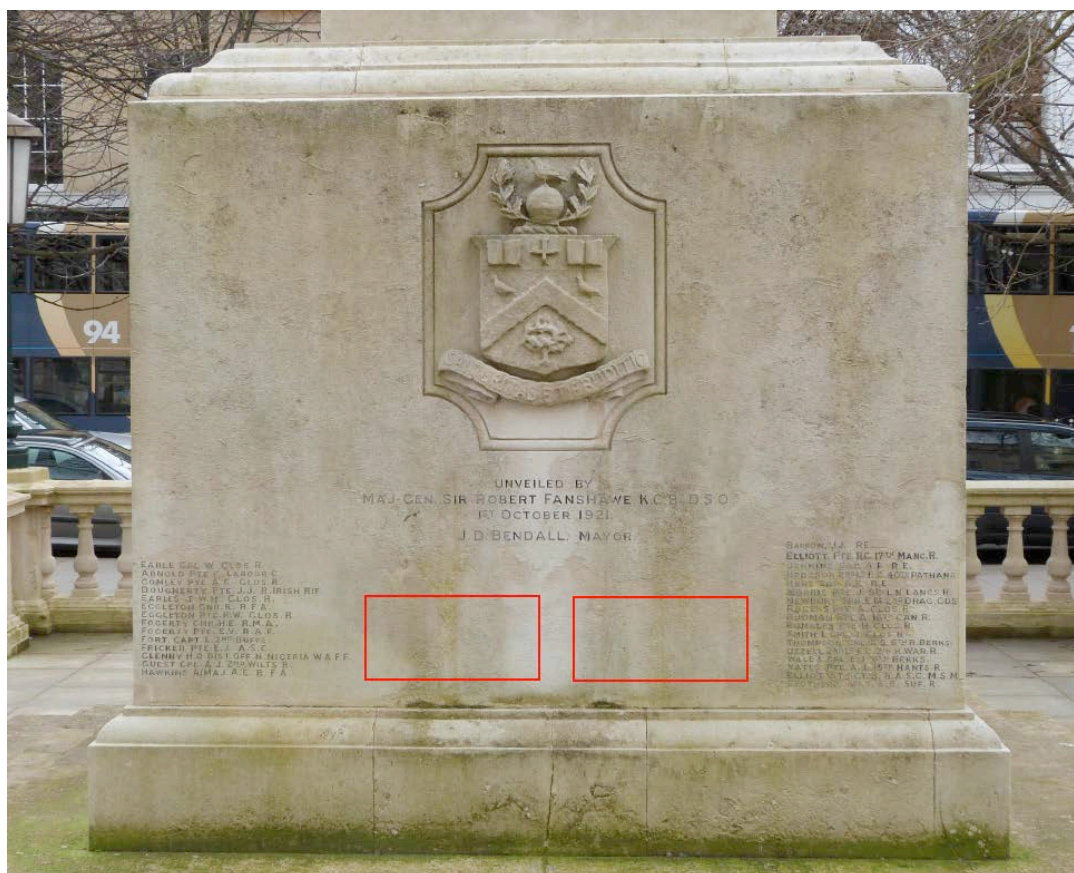
Fig 58: proposed location for new names

The number of new names to be included on the memorial is still under review but there are likely to be less than 20 in total. Given this, it would seem appropriate that the names are included on the main memorial. There already

exists a precedent as 31 names were added after the unveiling on the lower part of the west elevation inscription panel. There is room beneath the main inscription (without crowding or compromising the main inscription) for two columns of ten names (see Fig 58)
